Federal Building and Fire Safety Investigation  
of the World Trade Center Disaster

**Project #3: Analysis of Structural Steel**  
*Update*

June 22, 2004

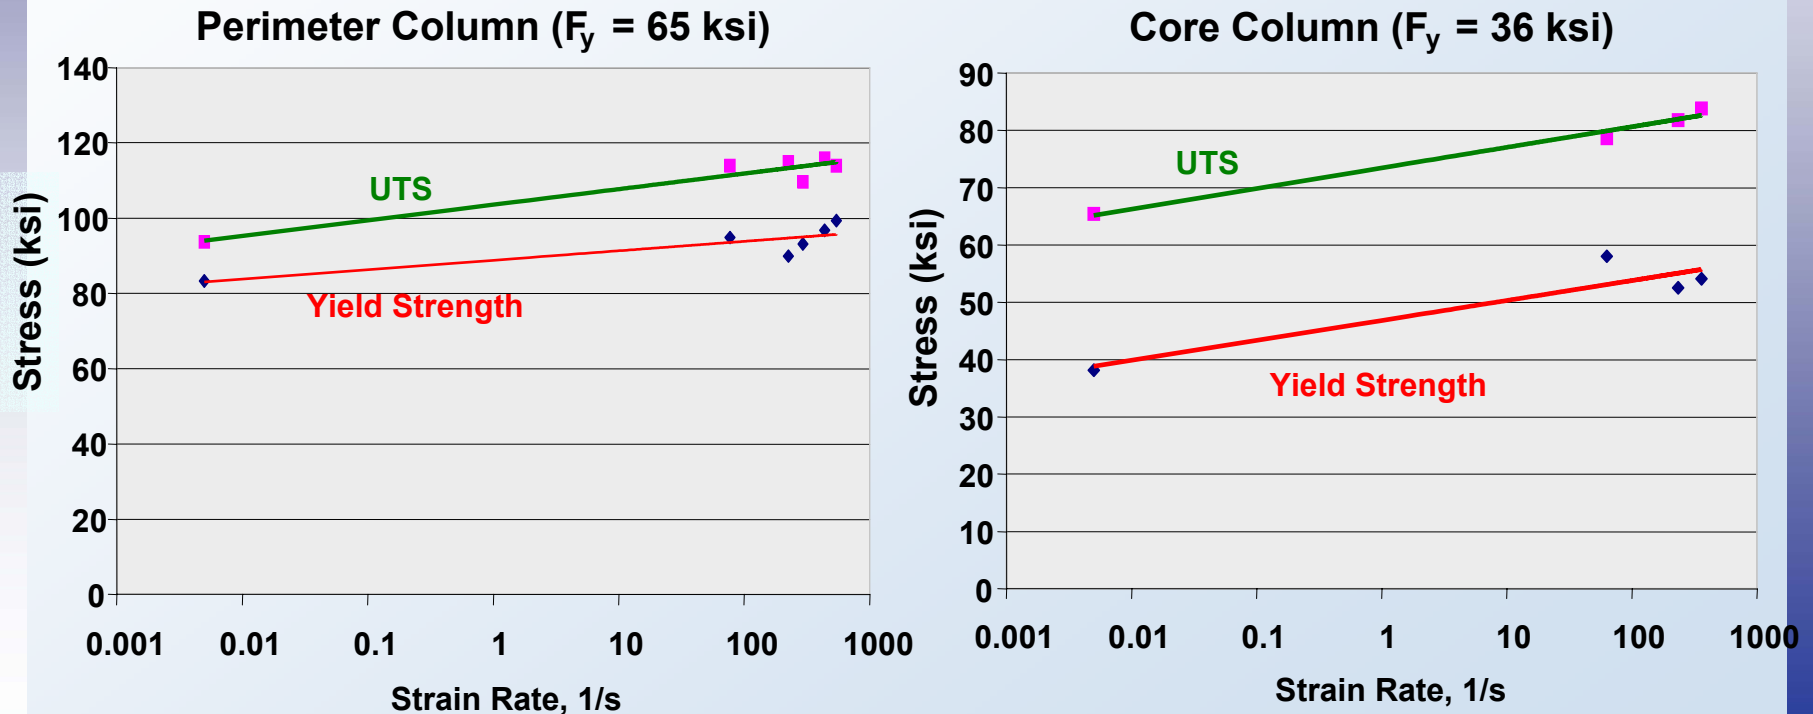
# High Strain Rate Behavior: Room Temperature

## Yield and Ultimate Strength Increase with Increasing Strain Rates

Higher strength of perimeter columns during impact results in greater reduction of aircraft's momentum. Such data allow more accurate modeling of damage to interior of building.

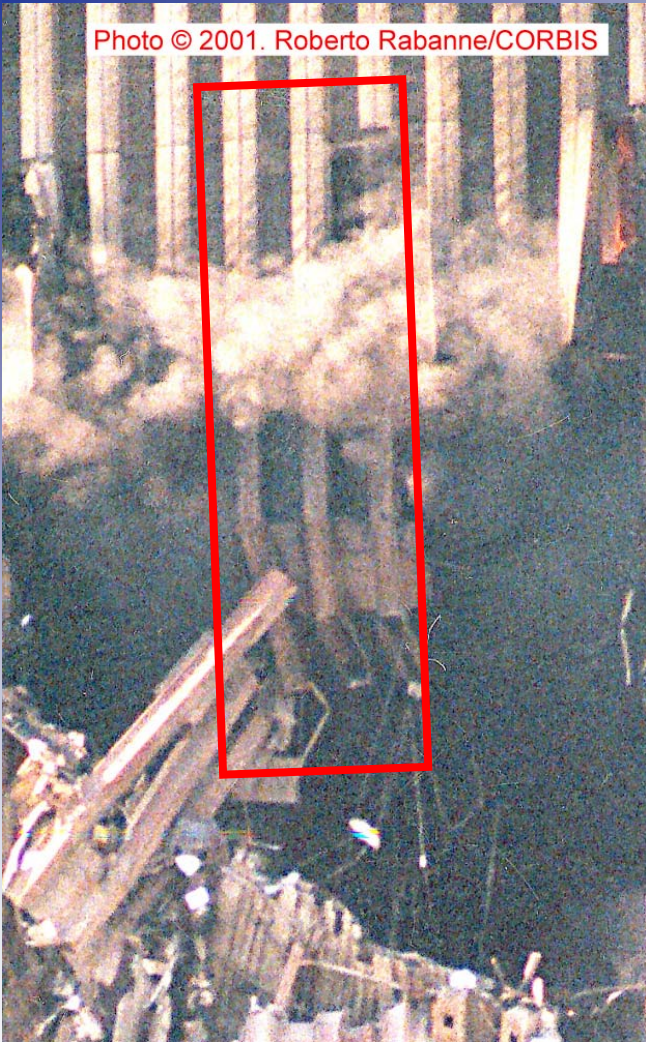
**NIST Name:** M-2  
**Panel ID:** A130: 96-99  
**Panel location:** WTC 1, North face  
**Window lines:** 28-31

- Recovered panels mapped for pre-collapse exposure to fire

- Paint condition used to map upper limits to temperature exposure
- Few perimeter panels (3 of 160 locations mapped) saw  $T > 250\text{ }^{\circ}\text{C}$
