PV modules' reliability deployed in Japanese PV power plant from viewpoint of encapsulant

December 8th 2015

Tsuyoshi Shioda
Mitsui Chemicals, Inc.

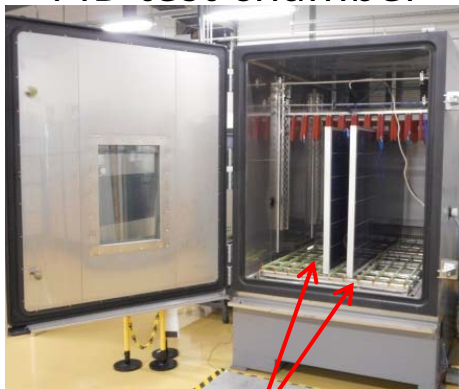
PID test chamber

Electroluminescence (EL) images after PID test

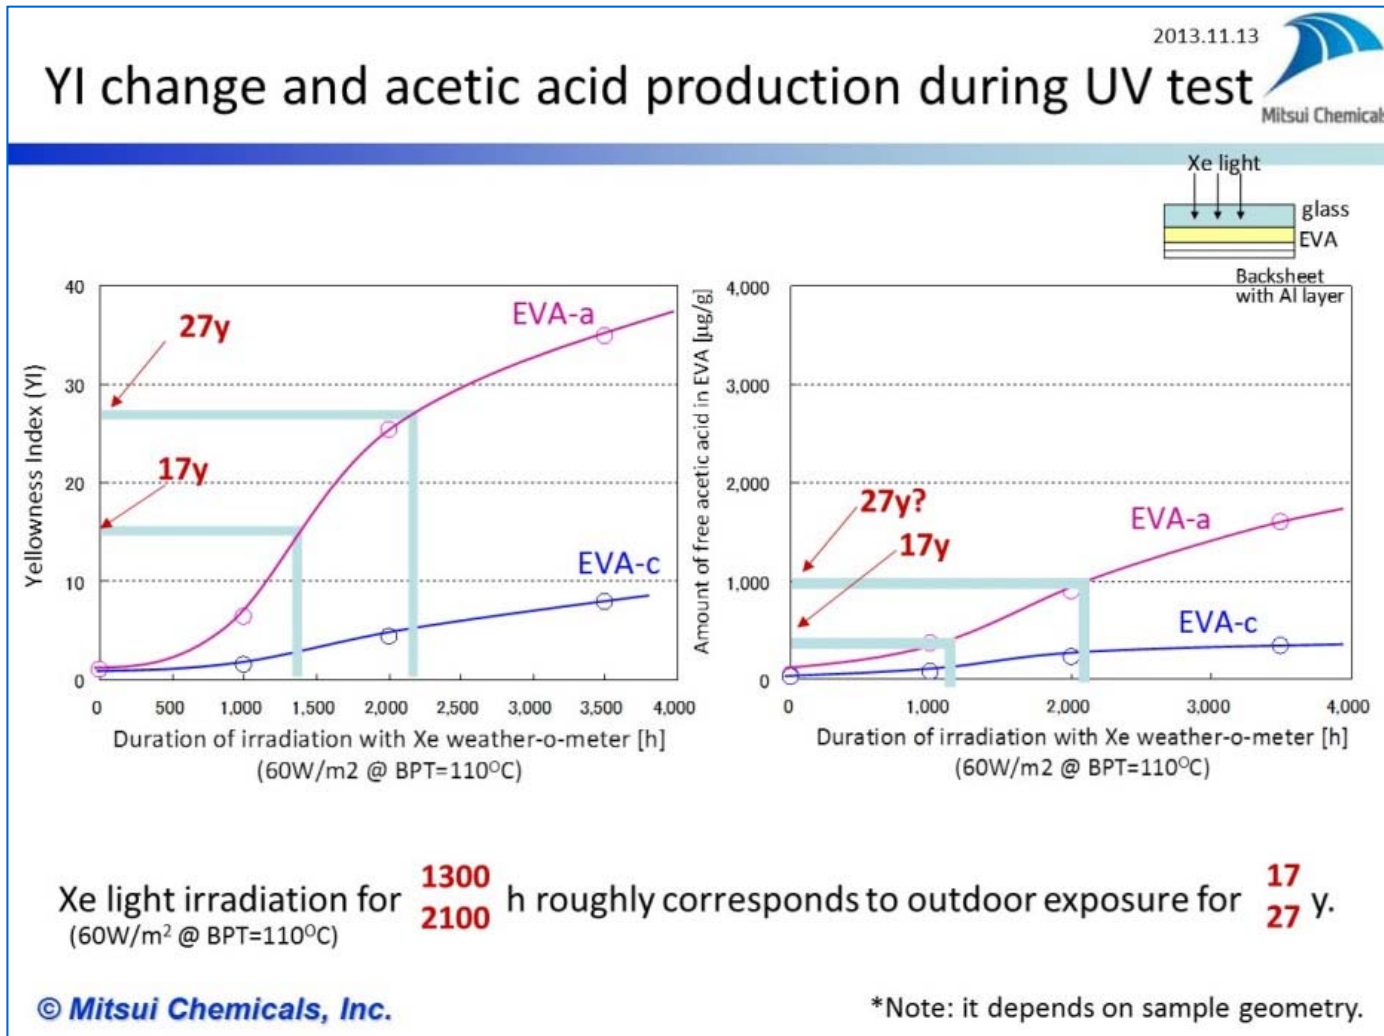
Degradation prediction of EVA with Xe light exposure

EVA encapsulant is one of key materials for reliability and durability of a PV module.

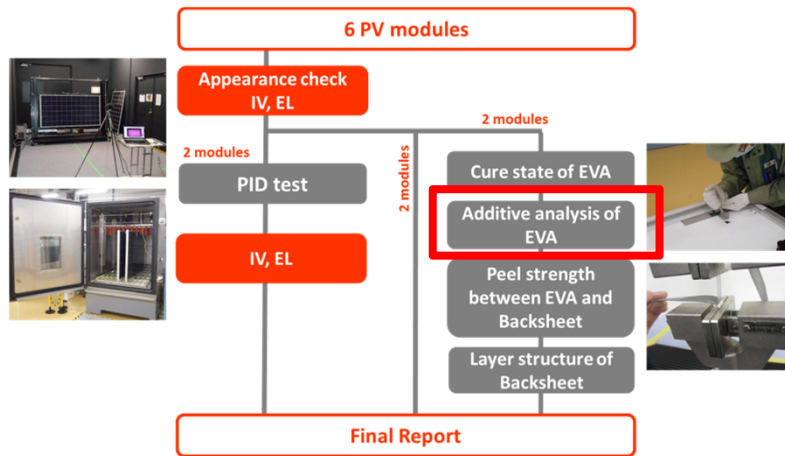
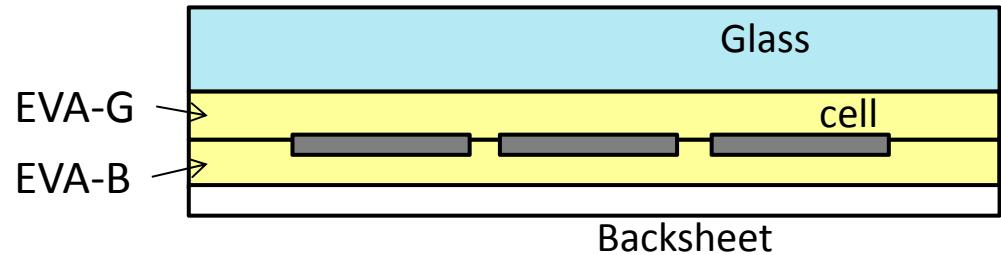
Recent trend of formulation from our additive analysis results

CASE (additive "A" related to light resistance)	2014	2015		
<table border="1"> <tr><td>EVA-G</td></tr> <tr><td>EVA-B</td></tr> </table> not detected not detected	EVA-G	EVA-B	~40%	0%
EVA-G				
EVA-B				
<table border="1"> <tr><td>EVA-G</td></tr> <tr><td>EVA-B</td></tr> </table> detected not detected	EVA-G	EVA-B	0%	~40%
EVA-G				
EVA-B				
<table border="1"> <tr><td>EVA-G</td></tr> <tr><td>EVA-B</td></tr> </table> detected detected	EVA-G	EVA-B	~60%	~60%
EVA-G				
EVA-B

- ✓ Some PV modules evaluated on 2014 have high risk of delamination according to our additive analysis.
- ✓ However the risk for those evaluated on 2015 would be low and not zero.
- ✓ We have to beware that function of UV absorber in EVA is mainly to protect backsheet against UV damage and completely differs from that of additive "A".
