# Challenges for Fuel debris retrieval with Robotics technologies at Fukushima Daiichi NPS

*February 3, 2016*

*Fukushima Daiichi Decontamination & Decommissioning Engineering Company,  
Tokyo Electric Power Company*

## *2. PCV Surveys with Robotics*

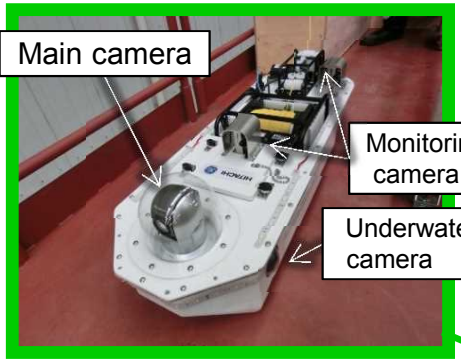
- Water leakage was found in sand cushion drain pipe. (November 2013)
- It indicates the possibility of D/W shell damaged.

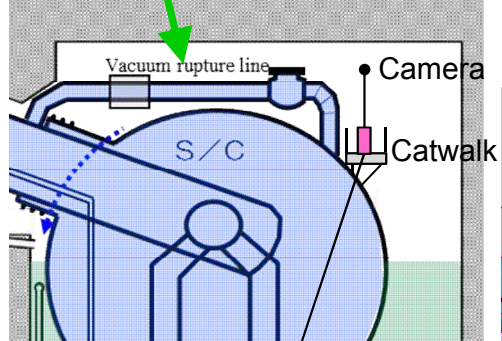
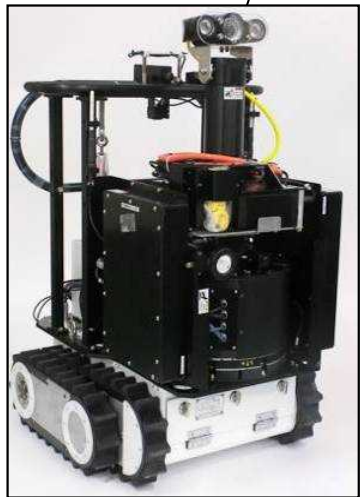
## Vacuum breaker line

- Water leakage was found at the bellows cover on the vacuum breaker.
- No other leaks were found. line (May 2014)

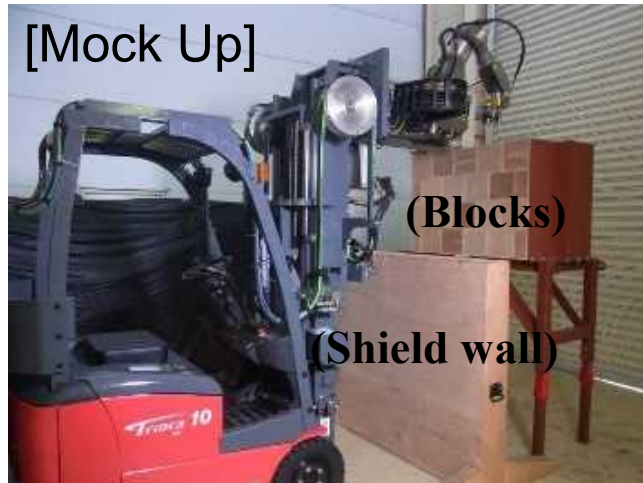
[Plan]  
Remote Robot Work  
(Shield block removal at X-6, Unit 2)

[result]  
Some Block Remained  
By block stuck and unexpected steel plate

- Unexpected stack of concrete blocks. Rust condition was difficult to predict.
- Unexpected steel plates.
- Unexpected structure of floor groove under the blocks.

[recovery]  
Man-Operated Work  
With heavy machinery
