4<sup>th</sup> Atlas/NIST Workshop on Photovoltaic Materials Durability  
December 5 – 6  
Session 4

# Short-term and long-term field experiences in Japan in terms of PV encapsulant

*Tsuyoshi Shioda*  
*Mitsui Chemicals, Inc.*

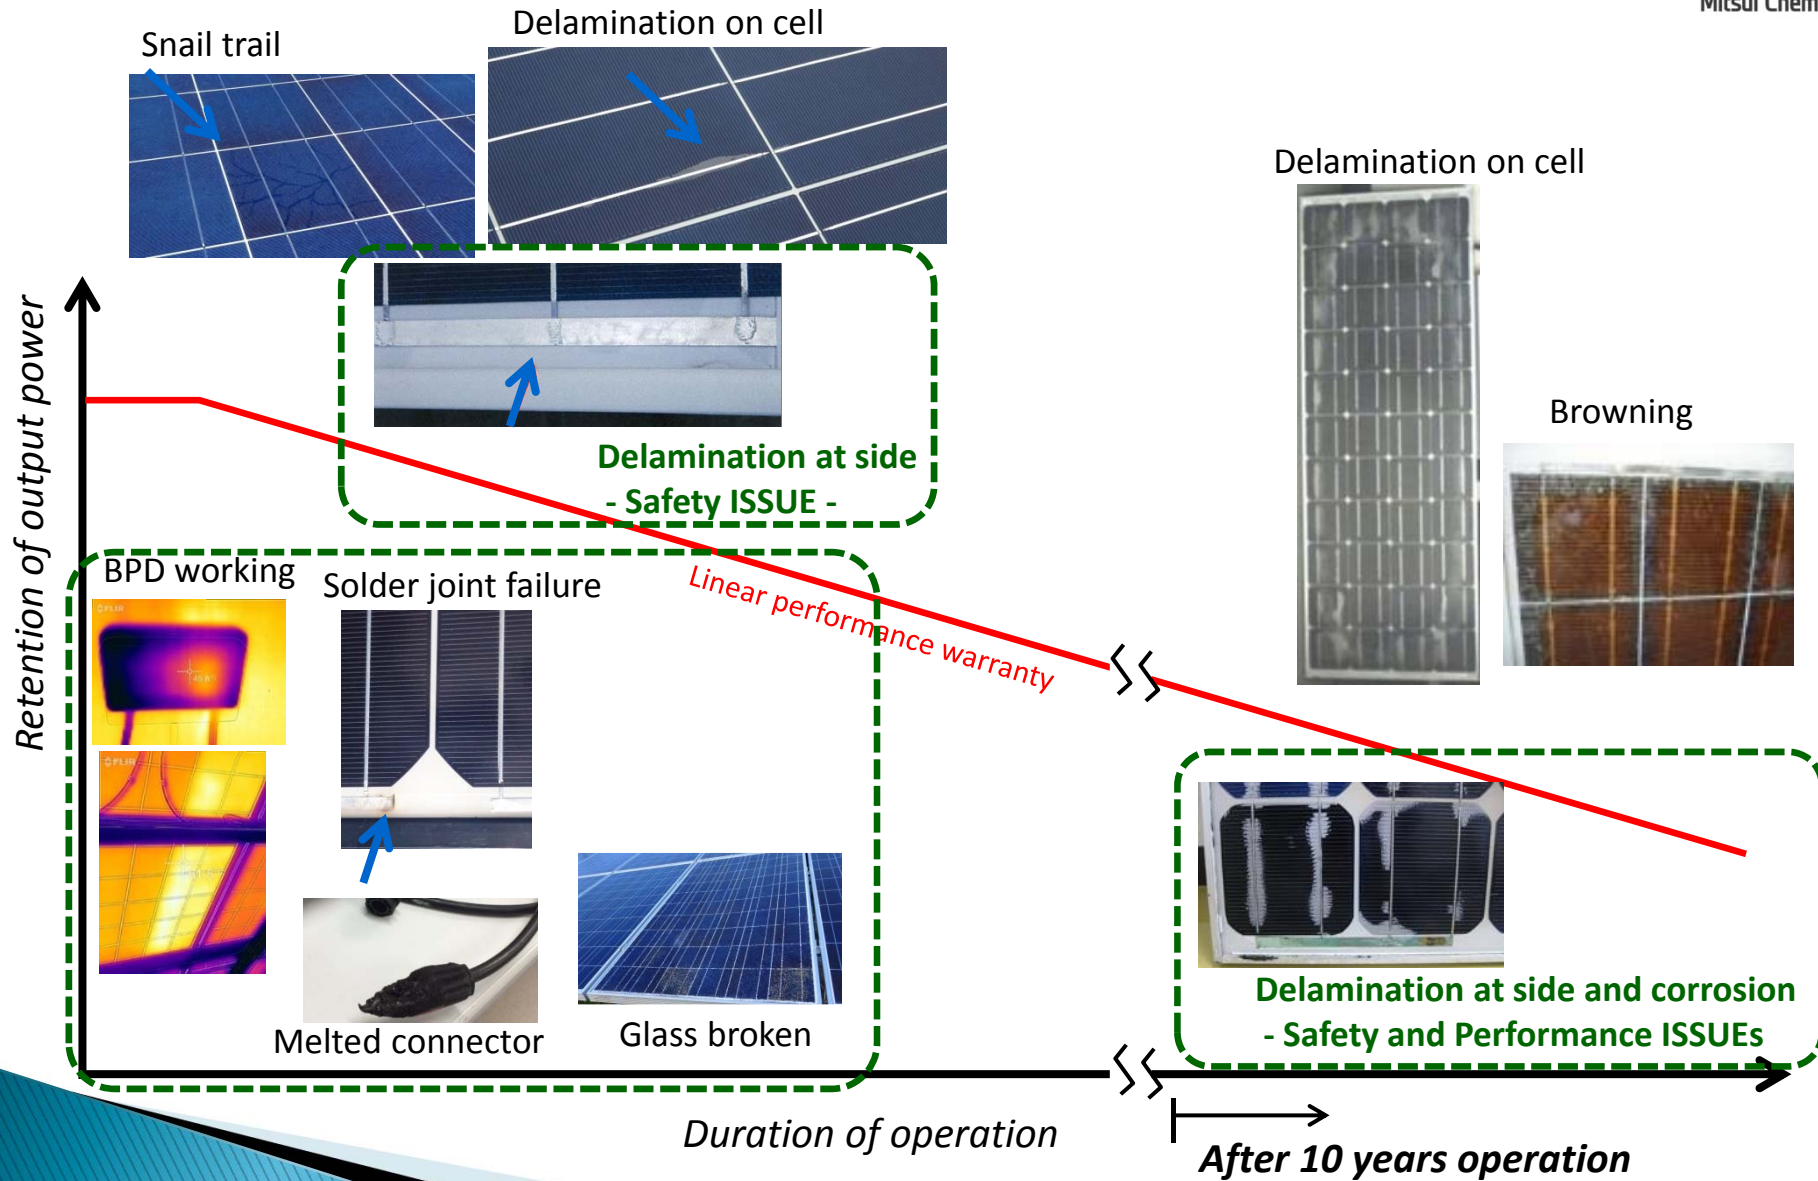
# ◆ Summary of findings observed in Japan

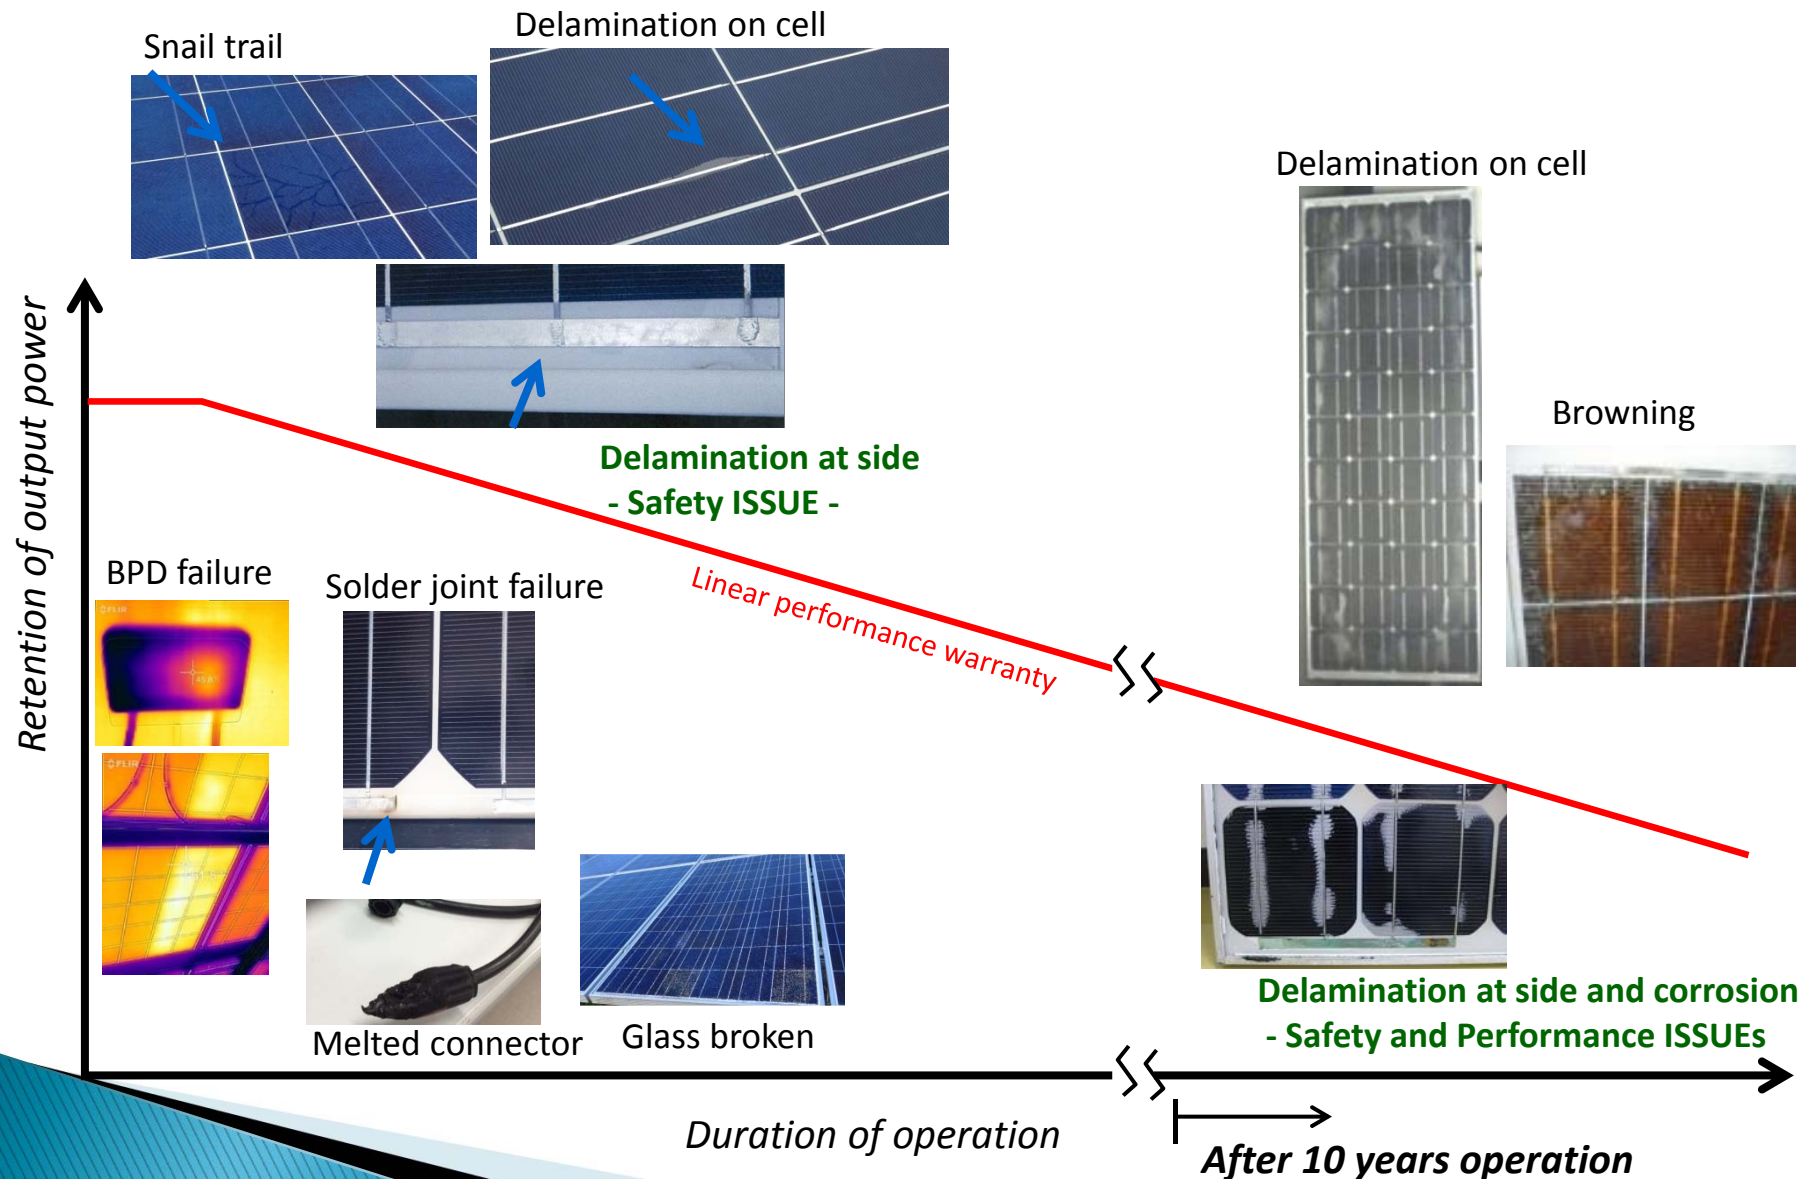
# ◆ Summary of findings observed in Japan

RISK	Failure	Probable cause -phase-	Severity	Frequency in Japan
Lower energy yield	Delamination on solar cell	Manufacturing	low	Medium
	browning	Design of EVA encapsulant	low	High (Aged) Low (recently)
	Snail trail	Manufacturing Shipping Installing	low	Medium
	Failed solder joint	Manufacturing	High	Low (Specific type / manufacturer)
	Broken glass	in operation	High	High
	Failed bypass diode	Manufacturing	High	Medium
	Melted connecter	Installing	High	Low
Safety  Electric shock, firing, stopping inverter, etc.	Delamination at side and corrosion	Manufacturing	High	Low (Specific type / manufacturer)
	Scratch of backsheet	Installing	Medium	High
	Failed solder joint	Manufacturing	High	Low (Specific type / manufacturer)
	Broken glass	in operation	High	High (Some case: long time deployed)
	Melted connecter	Installing	High	Low
