National Construction Safety Team Investigation

**Press Briefing: Draft Report on
The Station Nightclub Fire**

Providence, Rhode Island
March 3, 2005

**National Institute of Standards and Technology
Technology Administration
U.S. Department of Commerce**

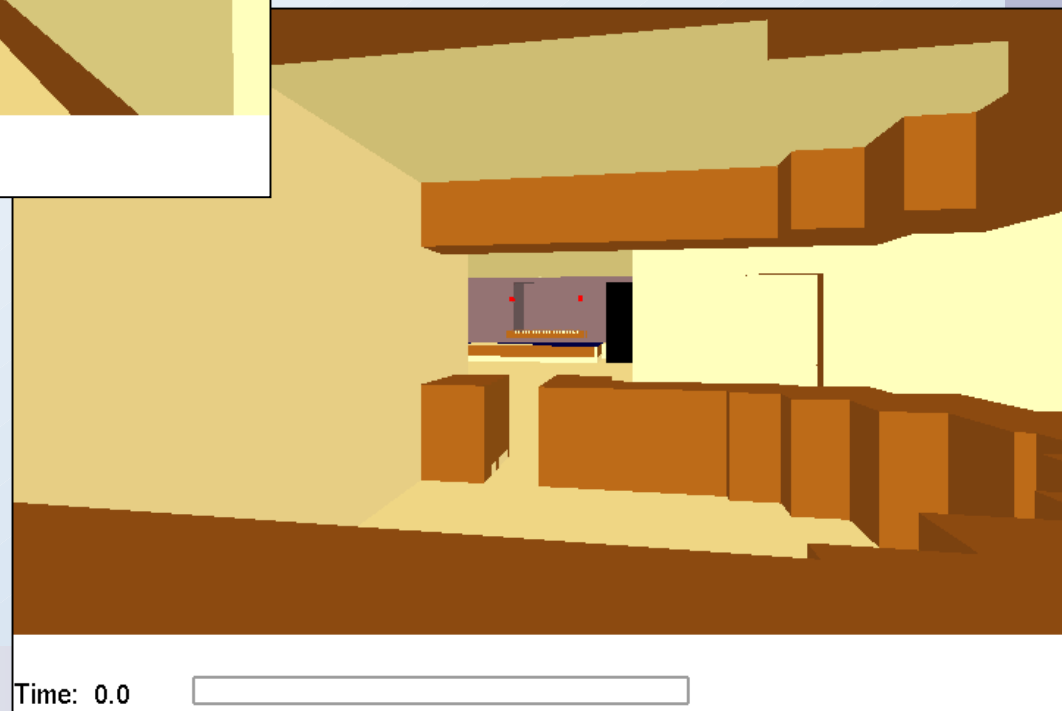
Temperatures in The Station at 90 seconds

(from computer simulation)

Peak temperatures in red exceed 1000 °C (1832 °F)

Light blue indicates temperatures around the boiling point of water (100 °C, or 212 °F)

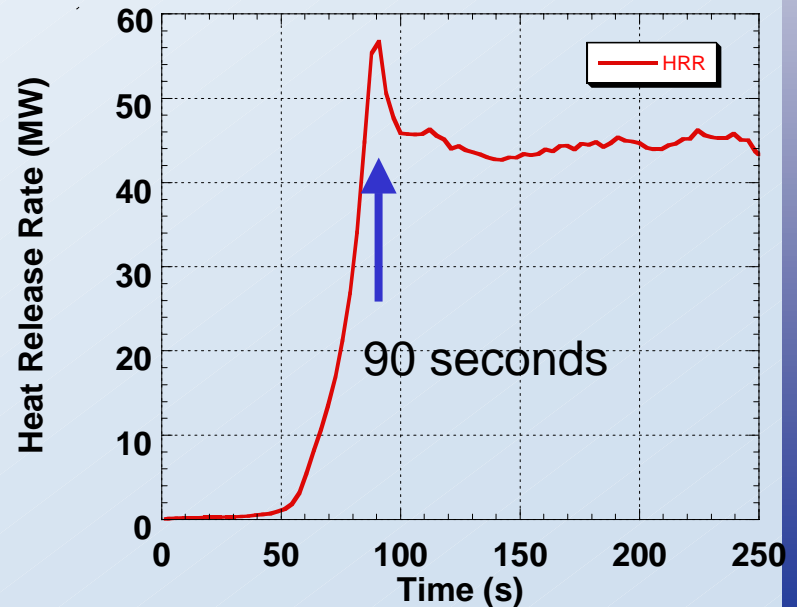
- Non-fire retarded foam sample purchased by NIST ignited within 10 seconds when exposed to a pyrotechnic device; under similar condition, fire retarded foam sample did not ignite.
- Computer simulation of the nightclub fire shows that flames spread rapidly over foam finish material, igniting the wood paneling adjacent to the foam and generating intense heat in the first 90 seconds.
- Fire transitioned to more traditional, ventilation-limited wood frame building fire in about 2 minutes.
