**DAMAGE ASSESSMENT REPORT**

Incident Name: Camp Fire      Recording Date: 12, 2, 18      Time Recorded: 11:55a  
Photo Release Form Approved:  Yes  No  N/A      Photo Numbers: 1997-2110

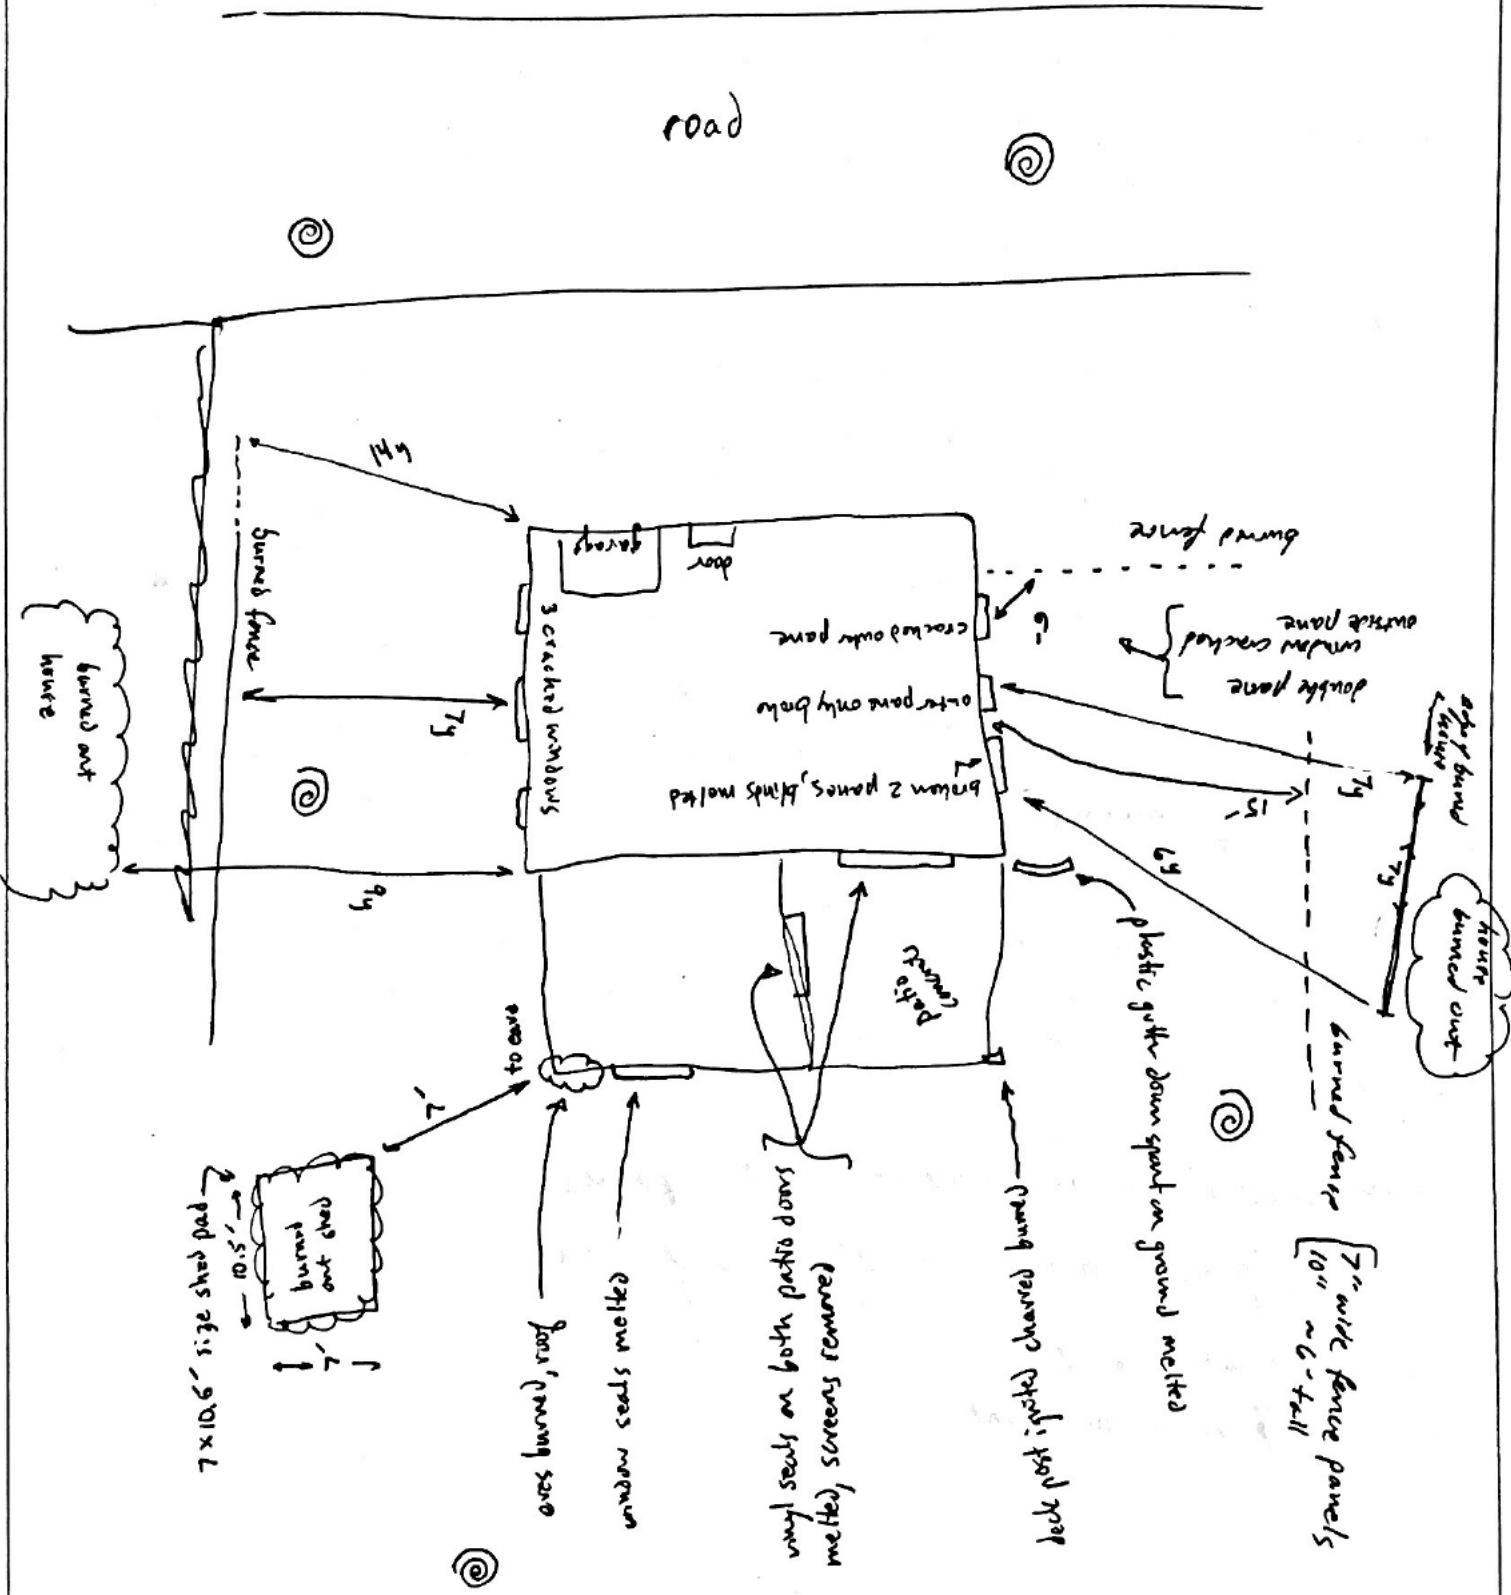
# 5 PARCEL SKETCH

- defended
- many cracked windows, some with both panes
- many different ignitions on all sides of house
- shed burned out behind
- horses on 4 sides burned out
