Use of Robotics and Remote Monitoring Equipment for Reducing Dose and Risk Associated with Radiological Work at Ontario Power Generation

Josip Zic

ONTARIO **POWER**
GENERATION

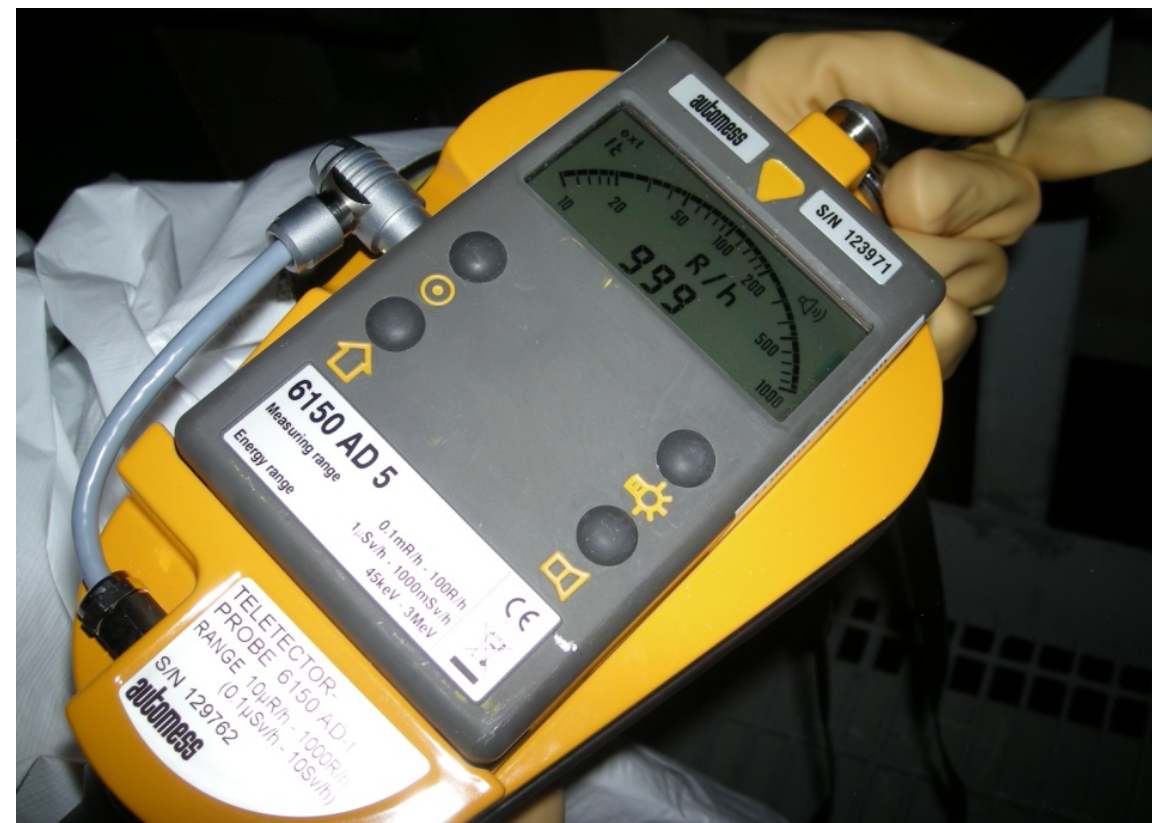
- A high hazard work plan was written to identify the source of the high radiation dose rates.
- Armed with a 14' Automess extension gamma meter the technicians looked for the source in the 80' by 20' maze of pipe work under the boilers.

• Surveys identified that the source of the unusually high dose rate was the Boiler 6 cold leg drain line.

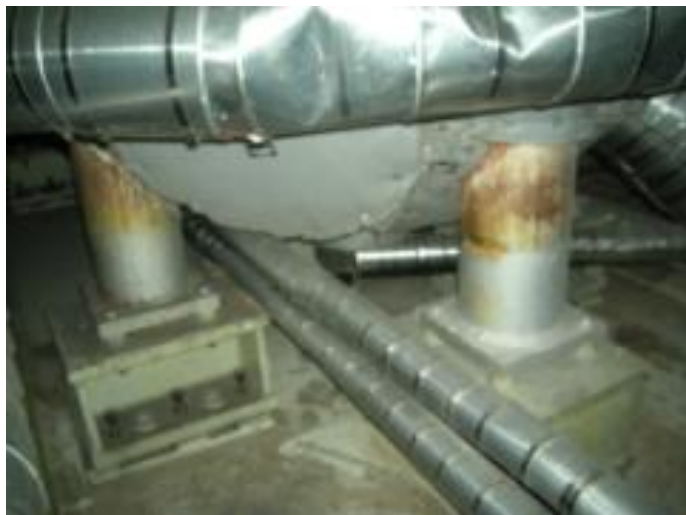
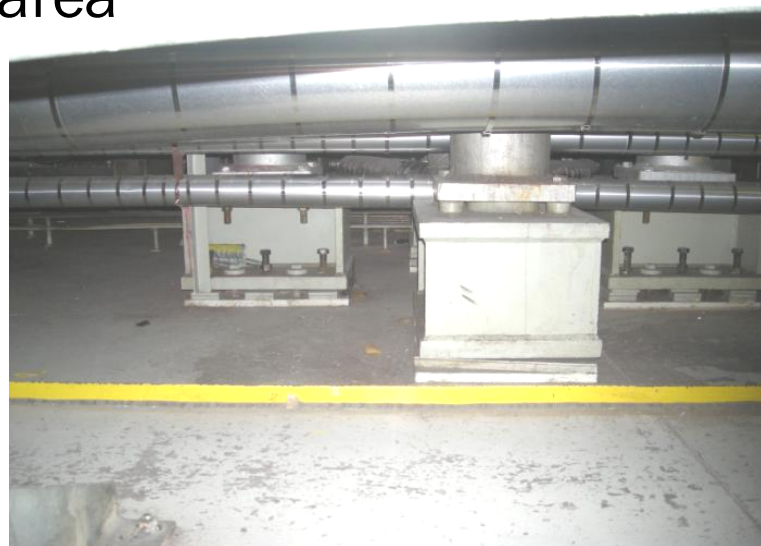
High Activity Debris in Boiler Cold Leg Drain Lines

- High activity debris (~35 Ci of Co-60) in the Boiler 6 Cold Leg Drain Line of Unit 4.
 - 500 rem/h working distance
 - 3.5 rem/h at 10'
 - 500 mrem/h at 20'
- Drain line located in very congested area

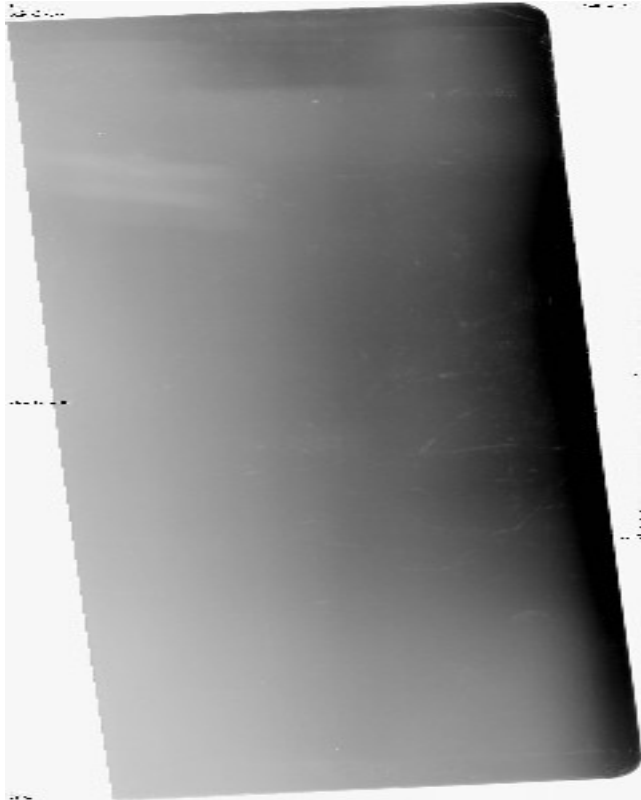
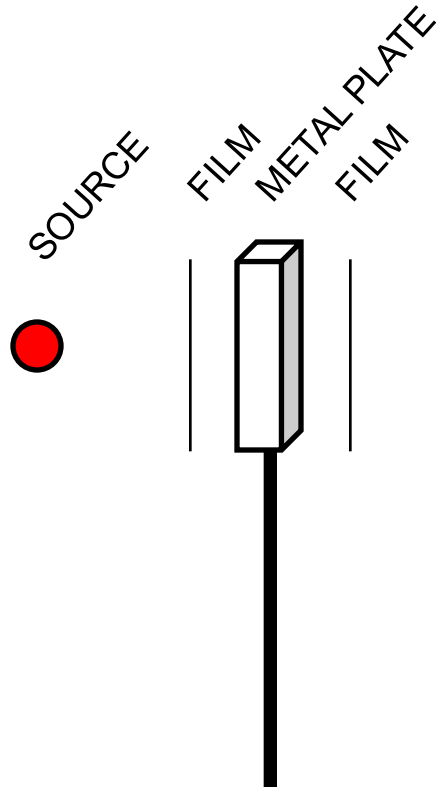
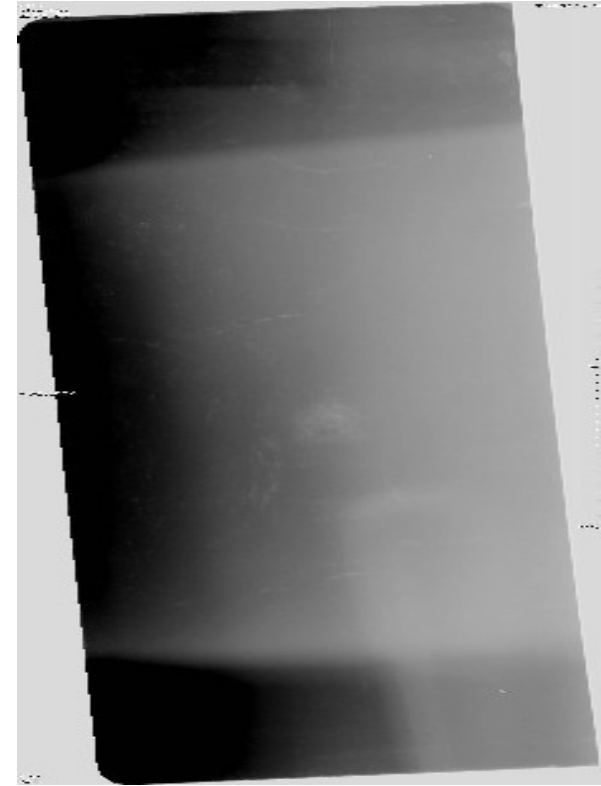
The best indication of the location of the source, prior to execution, came from using radiography film.

COLD LEG

BOILER BOWL

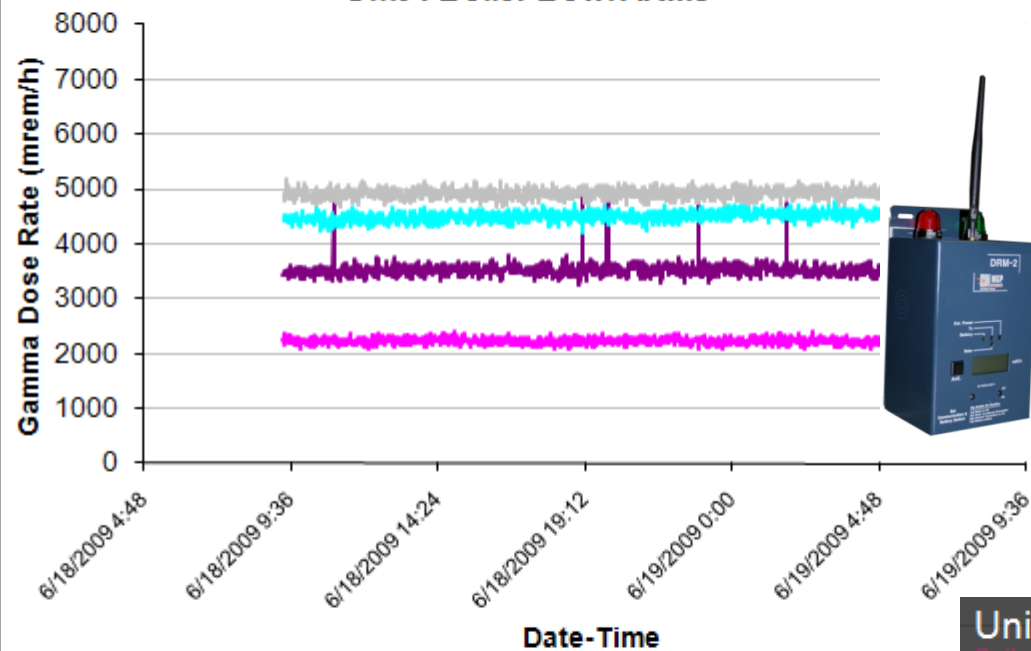
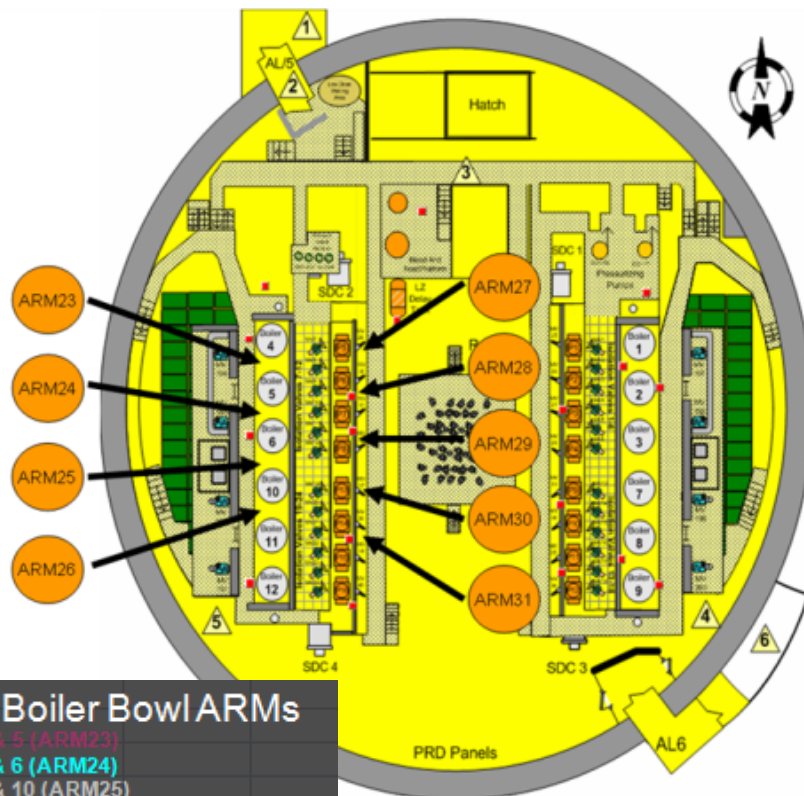
Unit 4 Boiler Bowl ARMs

- Real-time monitoring during Unit operation (DRM-2)

- Boilers 4 & 5 (ARM23)
- Boilers 5 & 6 (ARM24)
- Boilers 6 & 10 (ARM25)
- Boilers 10 & 11 (ARM26)

- PHT Pit MV29 (ARM27)
- PHT Pit MV30 (ARM28)
- PHT Pit MV31 (ARM29)
- PHT Pit MV32 (ARM30)
- PHT Pit MV37 (ARM31)

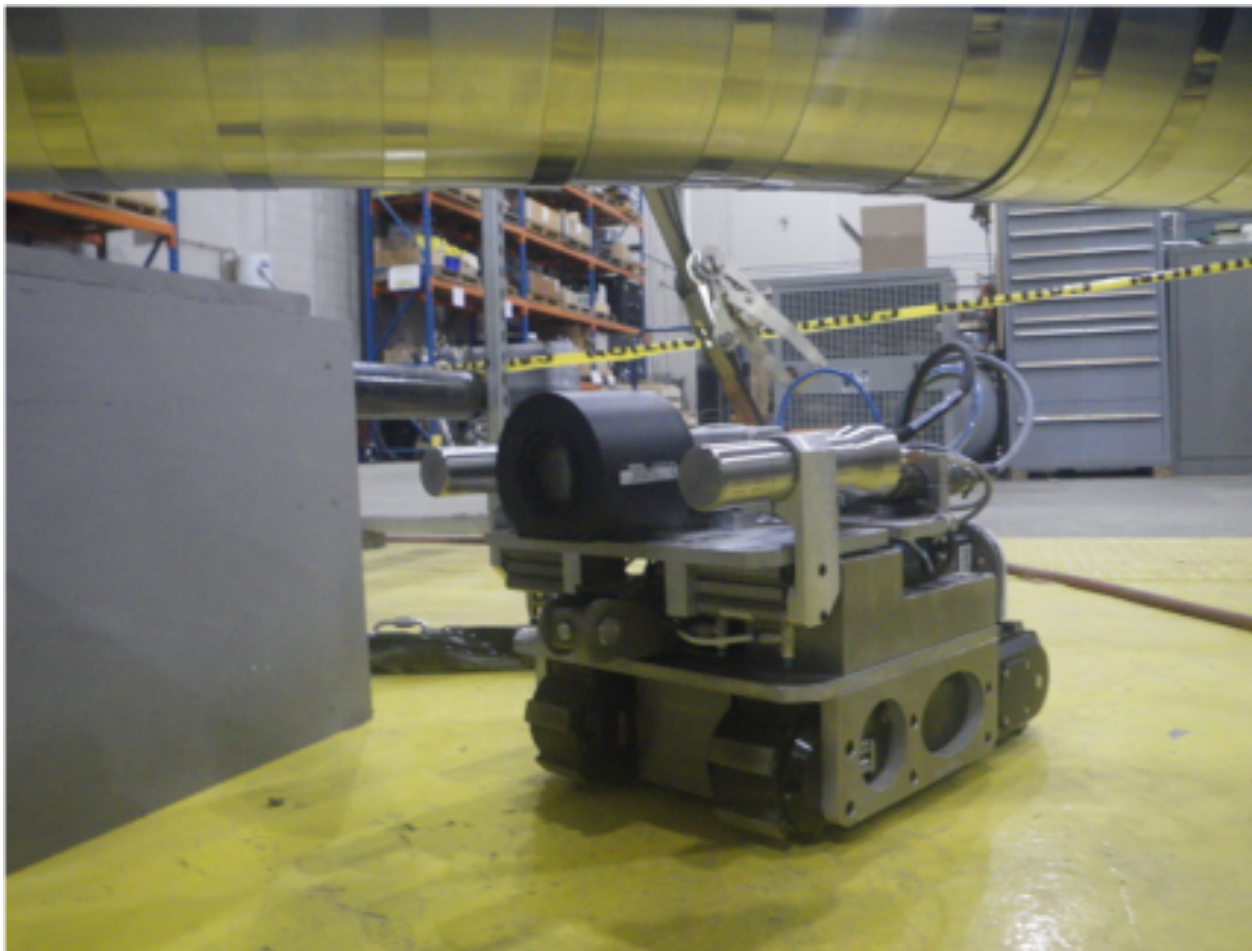
WALL-E

- Gamma Camera Robot

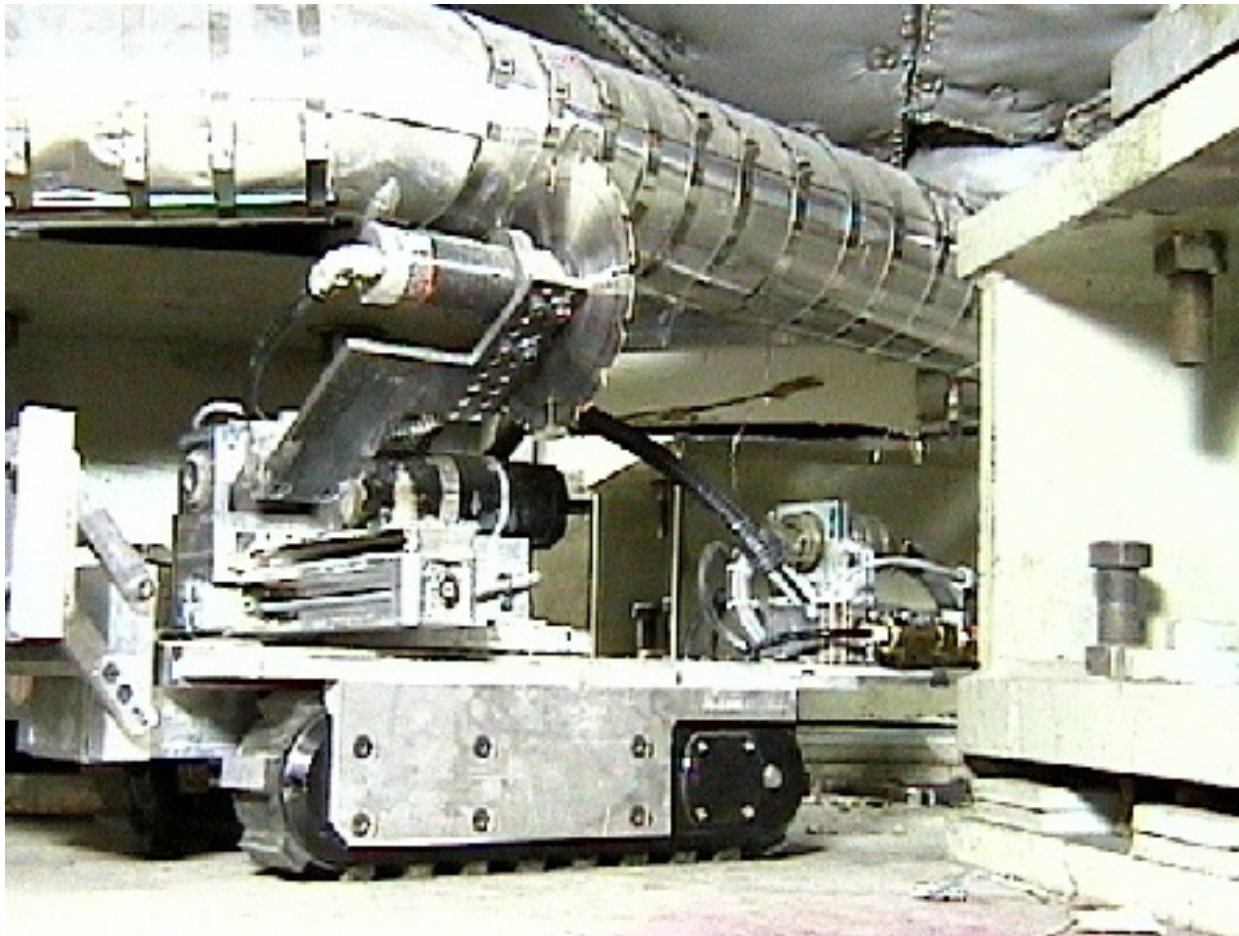
MATER

- Insulation Removal Robot

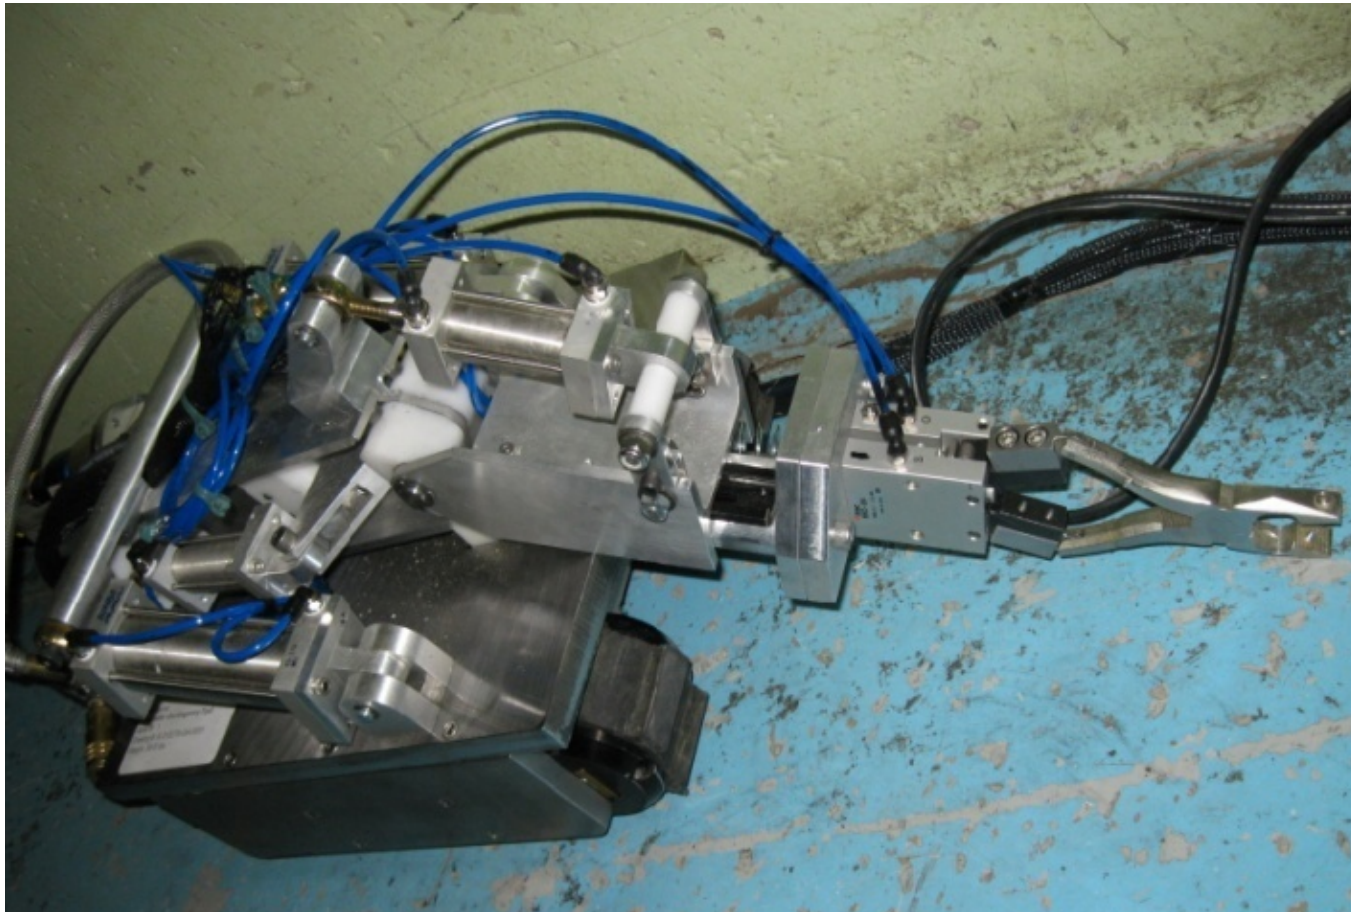
OPTIMUS
PRIME

- Contingency Robot

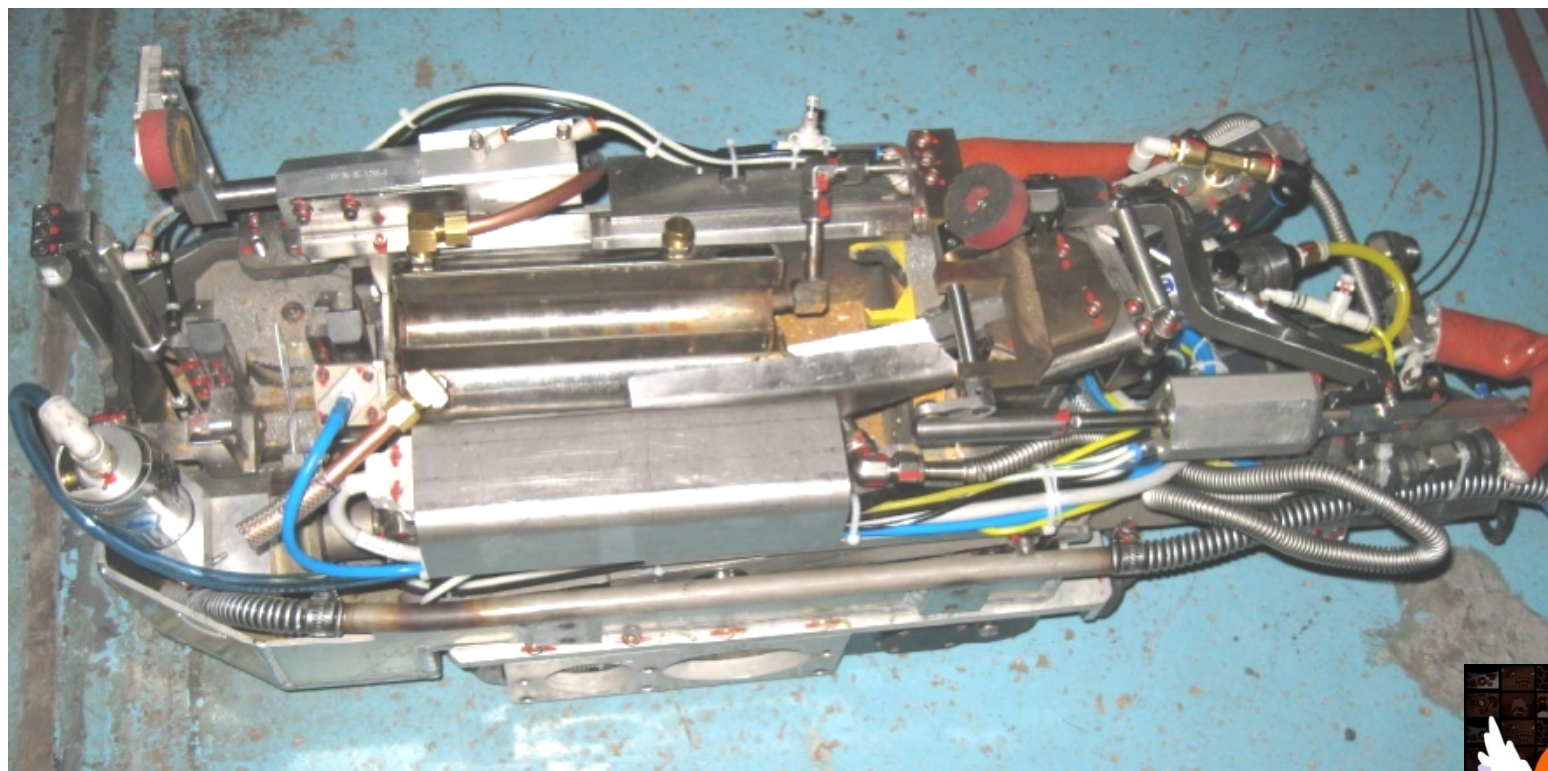
KENNY

- Freeze-Cut Robot

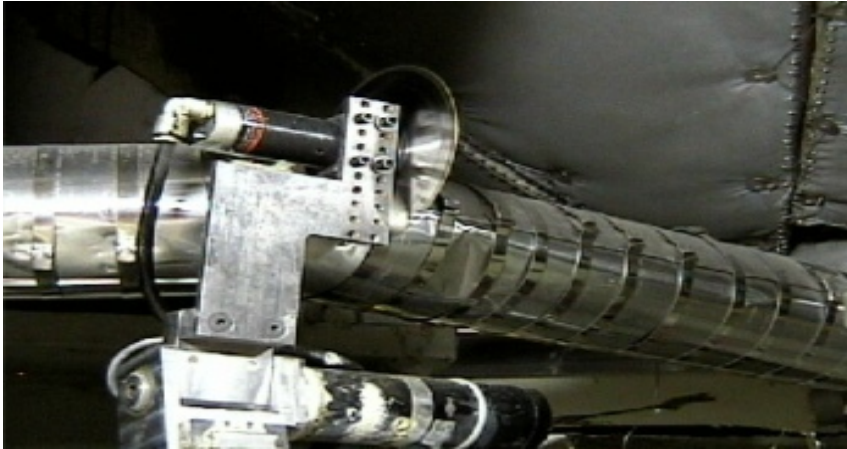
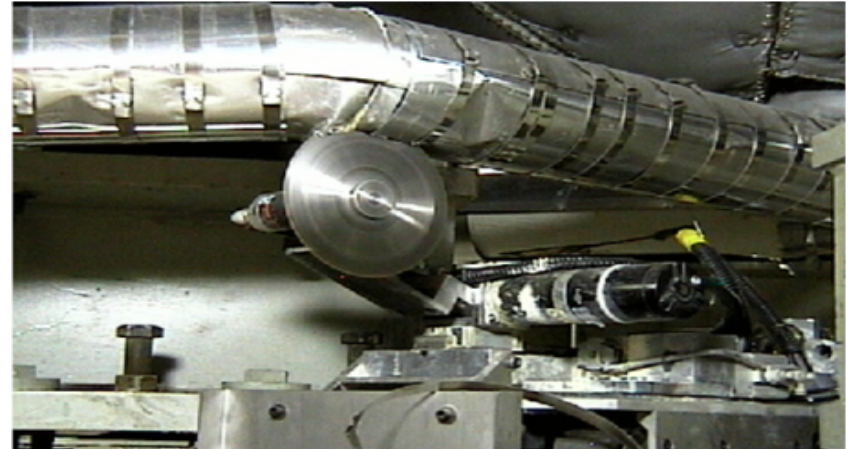
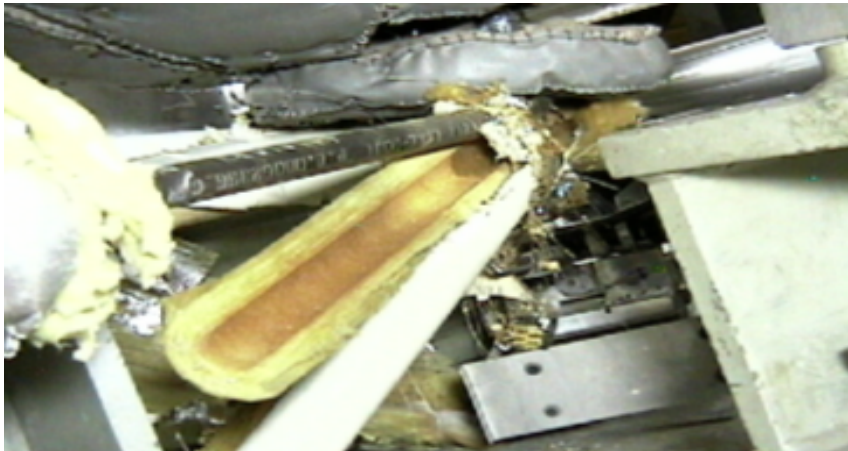
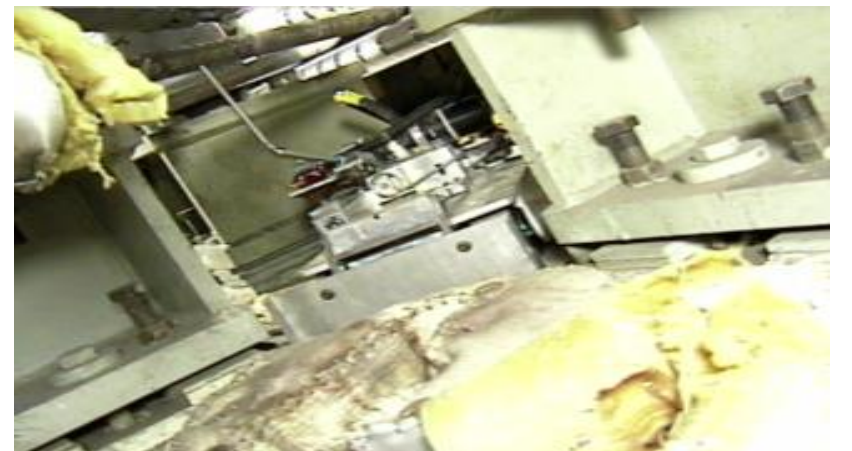
- Insulation Removal

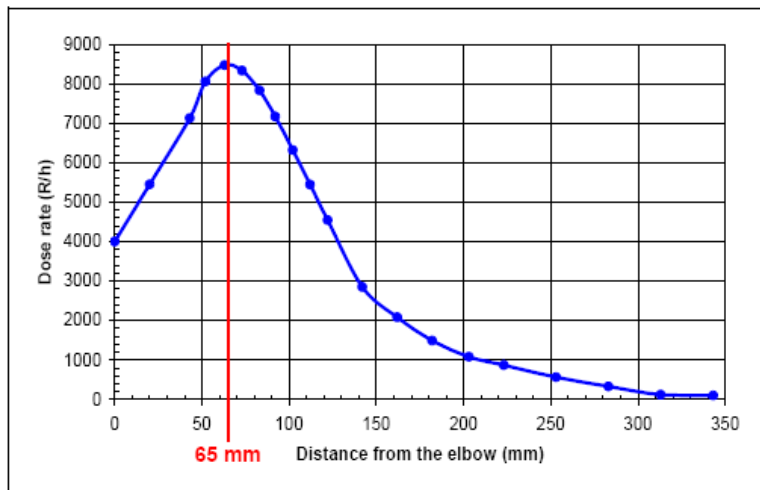
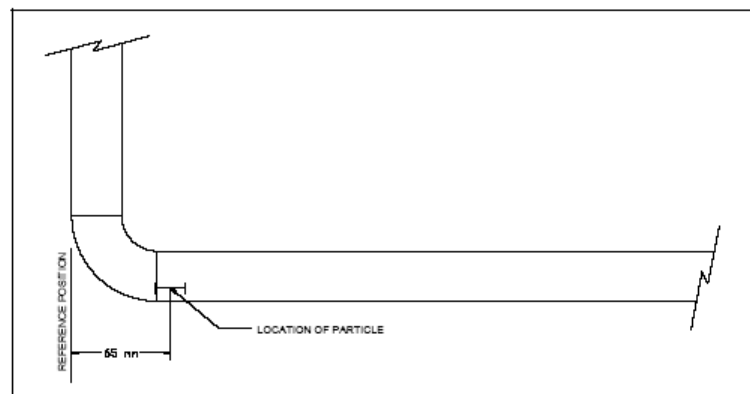
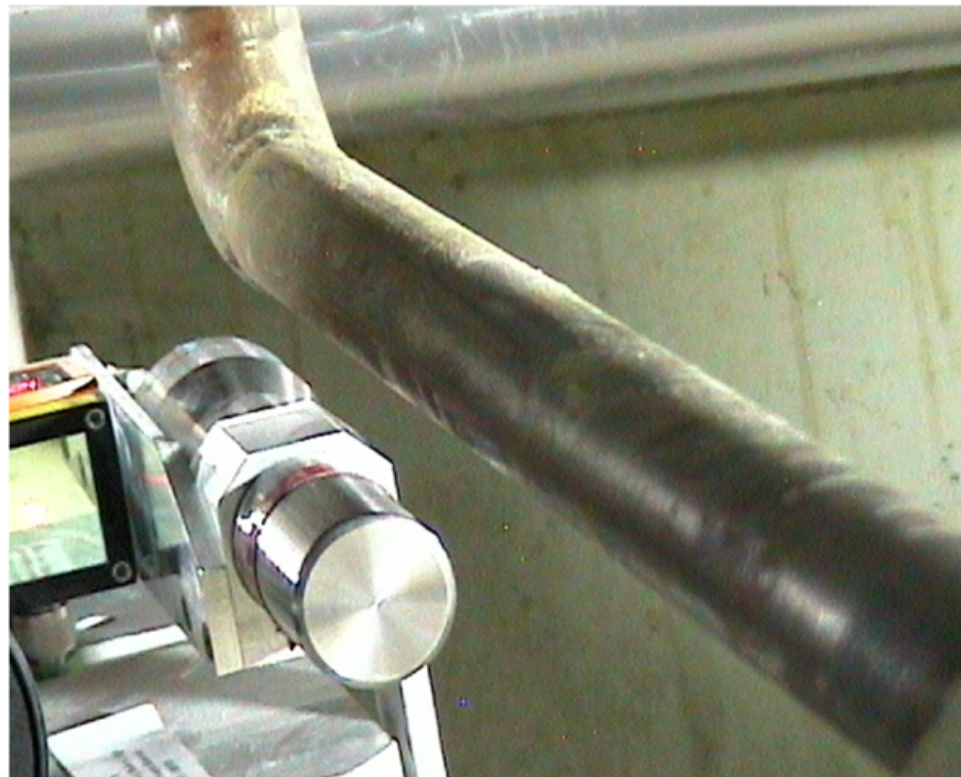
■ Verifying Source Location

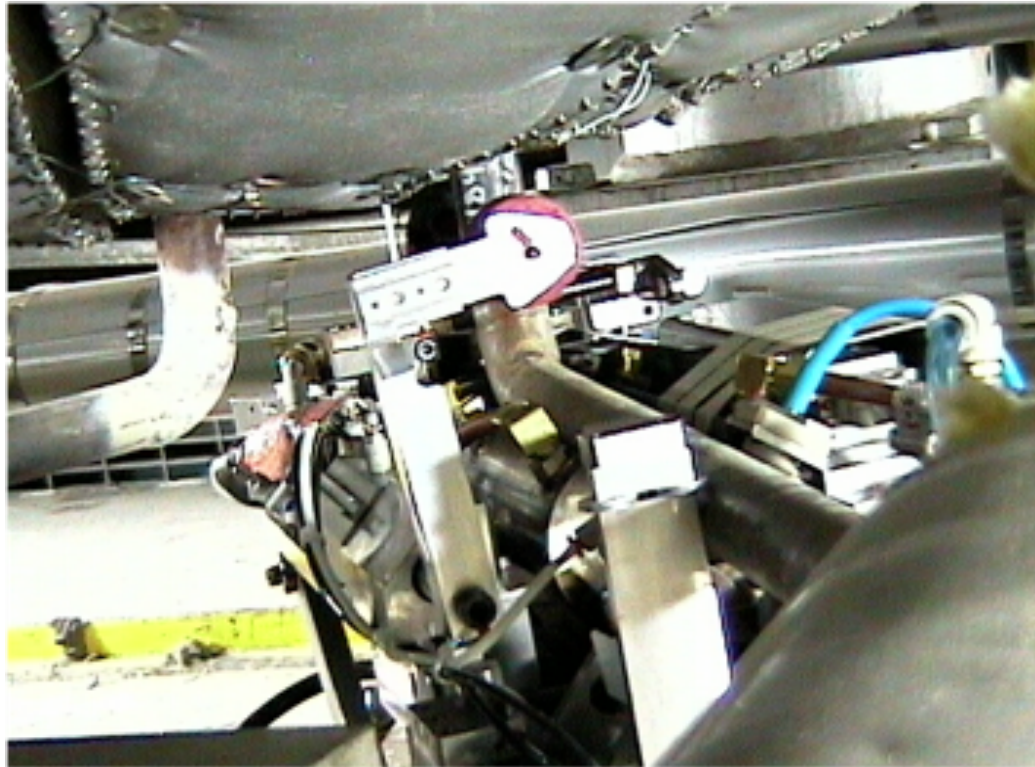
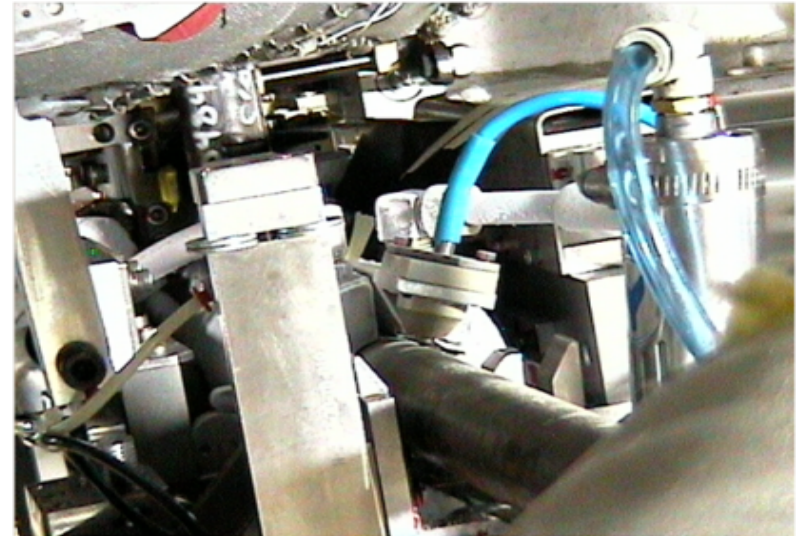
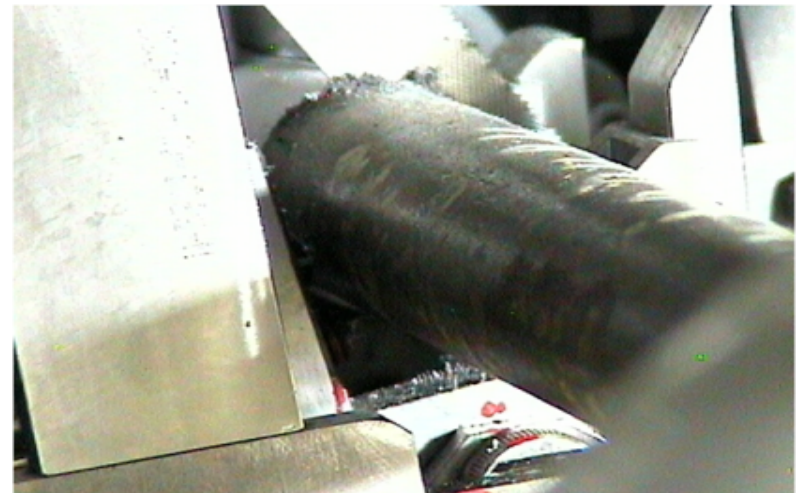
- Freeze Cut and Cap

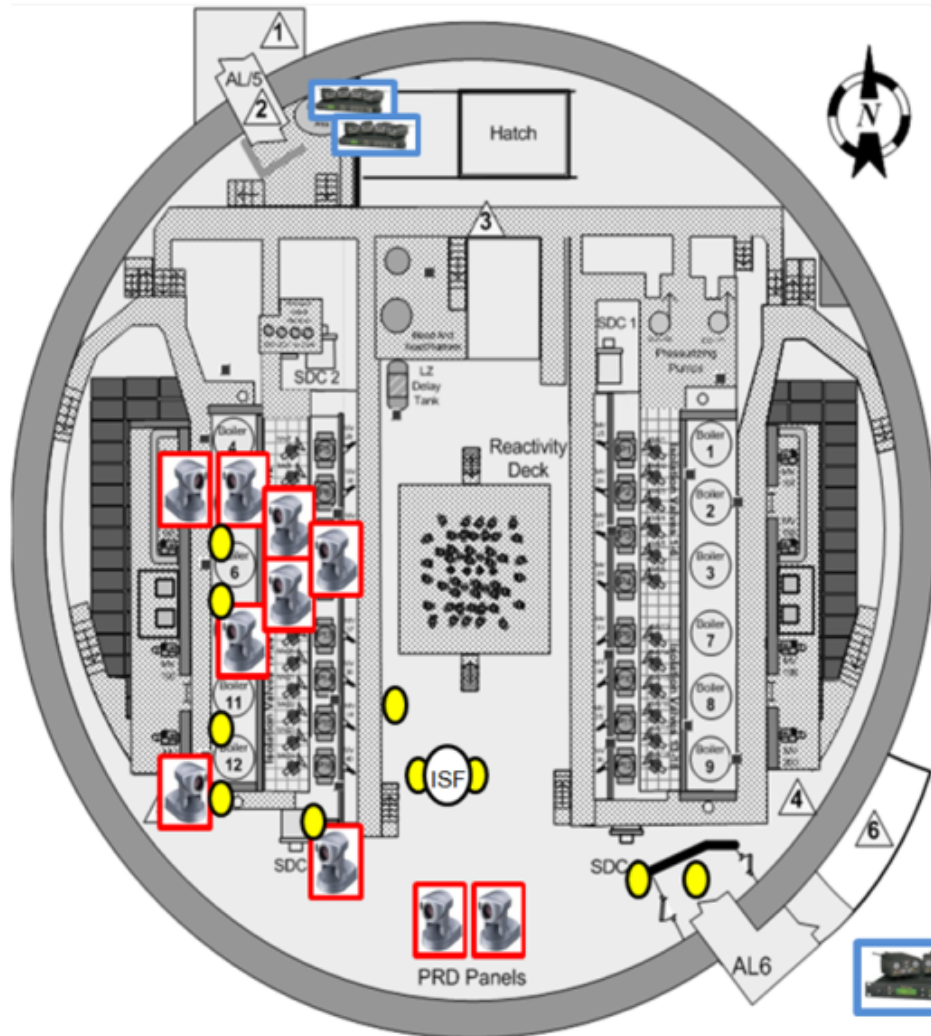
- 10 Video Cameras + 3 Added Later
- 10 Area Radiation Monitors
- 8 Wireless Communication Packs

- Minimize number of staff in area
- Maximize safety of execution staff
- Track movement of High Activity Debris

Network Camera

Area Radiation Monitor

Wireless Communications

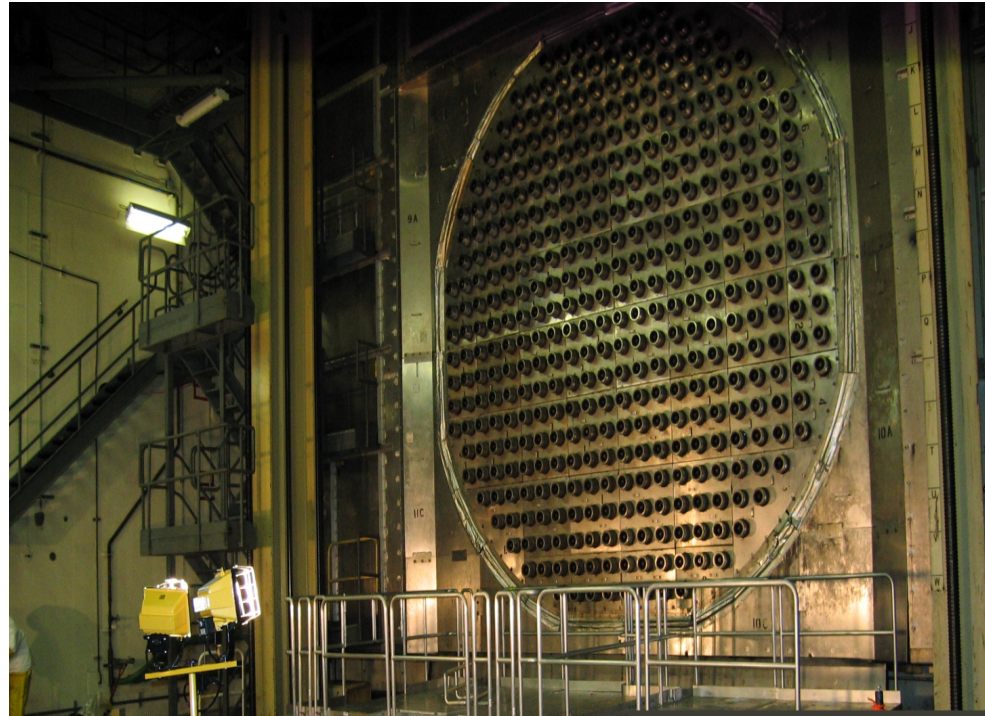
- Current Method:
 - Remote monitors on F/M Bridge
 - 2-3 hours of critical path
- Proposed Method:
 - Automated drones
 - Off-critical path
- Challenges
 - Time required to measure up to 390 channels, with current battery limitations of drones
 - Positioning of drone without GPS
 - Additional weight of gamma detector and transmitter
