IMPORTANT!!! PLEASE READ BELOW

Dear Charpy Machine Verification Program Customer,

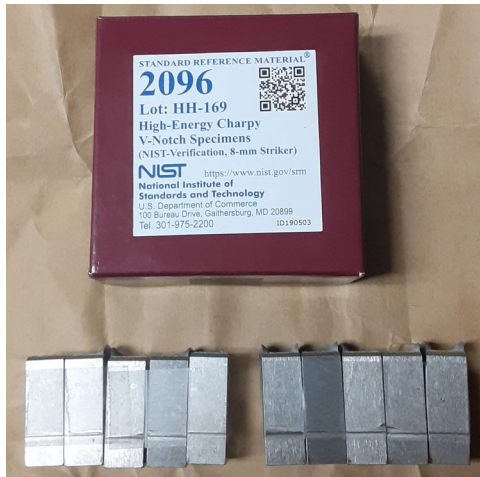
- (a) Taking pictures of broken specimens together with the box(es) that contained the samples when they were purchased (see example below).

- Take photos of the specimens grouped or taped together (with transparent scotch tape only, please) **so that the marks left by the anvils are clearly visible** and can be examined, as in the examples shown below.

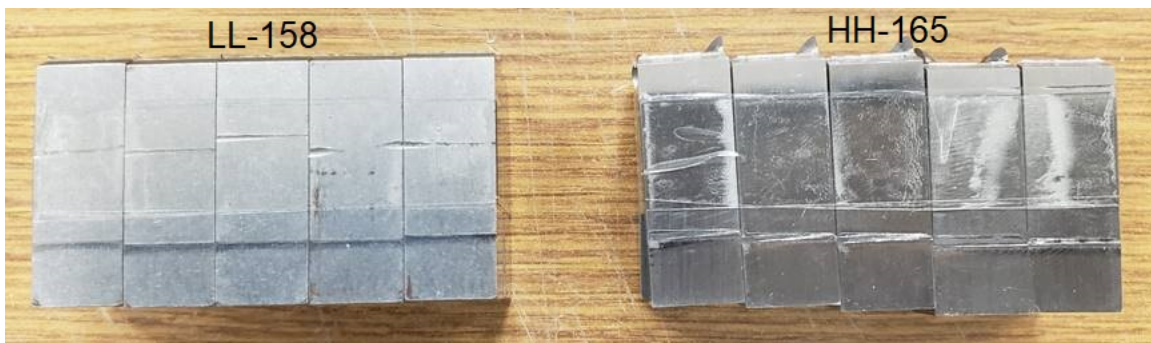
(b) Adding a label to the photo, indicating which lot pictured specimens come from (see example below).

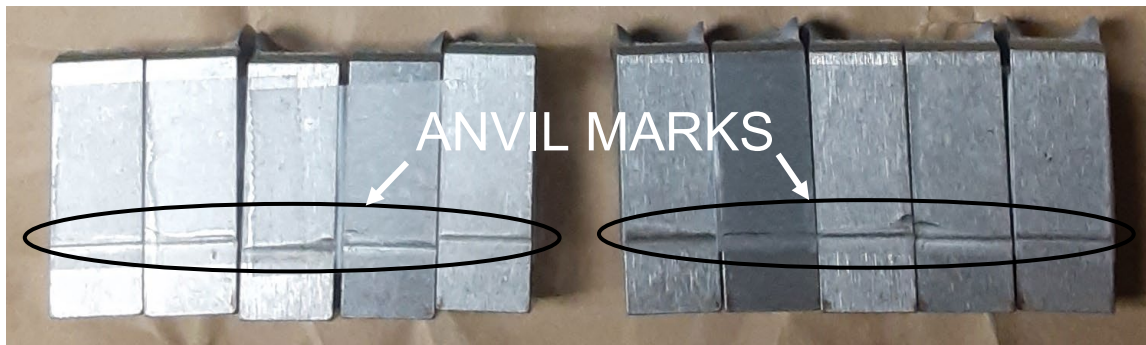
Again, what we need to examine in the photos are primarily the marks/indents created by the anvils on the specimens during the fracture process (see below).
