# DEGRADATION STUDY OF FIELDDED PV MODULES FROM DIFFERENT CLIMATES IN CHINA

Dec 8<sup>th</sup>, 2015

Xian Dong

Shunde SYSU Institute for Solar Energy

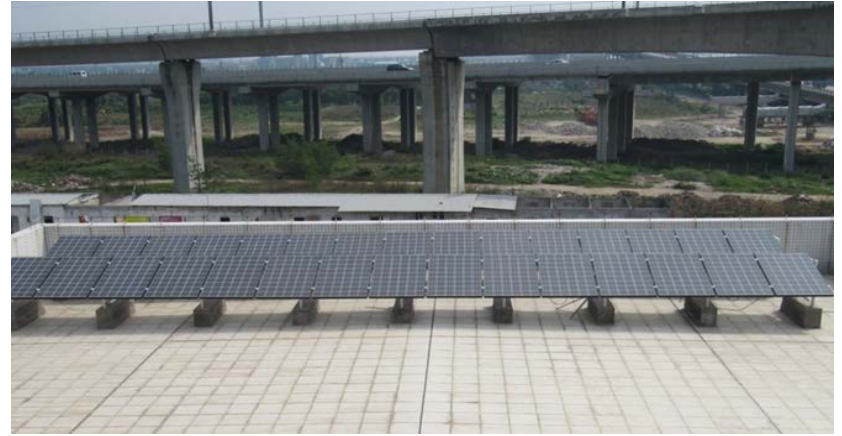
Appearance of Kyocera module systems

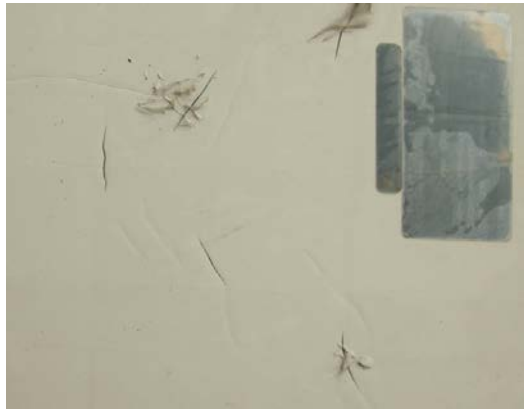
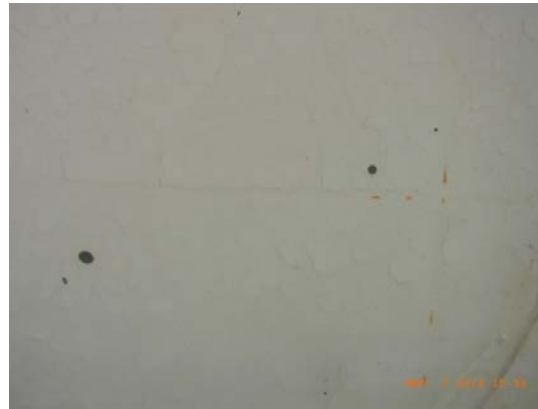
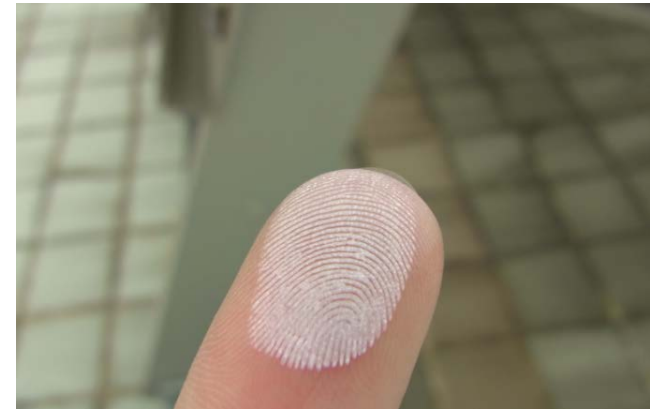
## Backsheet pulverization

Sample from Solarex module

New backsheet-Tedalar PV2001

- (a) Sample from Solarex module
- (b) Sample from Solarex module-covered by the label
- (c) Tedlar PV2001
