# Update on NIST's Investigation of the Partial Collapse of Champlain Towers South in Surfside, Florida

Judith Mitrani-Reiser  
*Lead Investigator*

**STRUCTURES CONGRESS 2025** | [structurescongress.org](https://structurescongress.org)

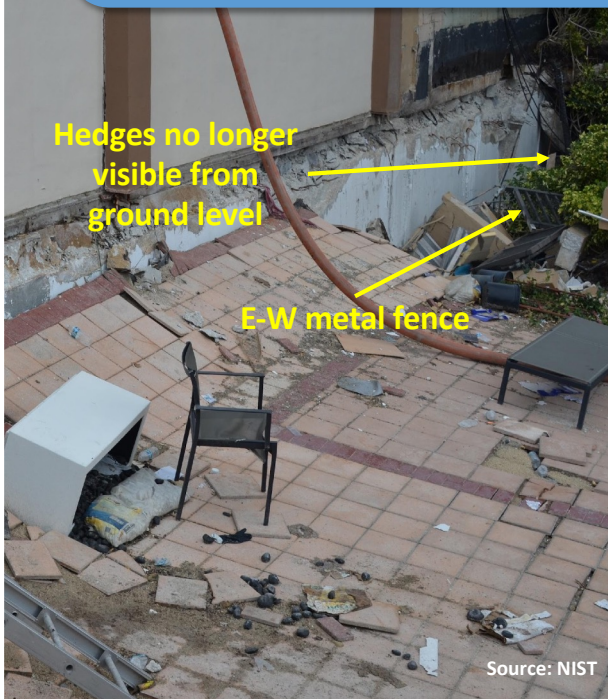
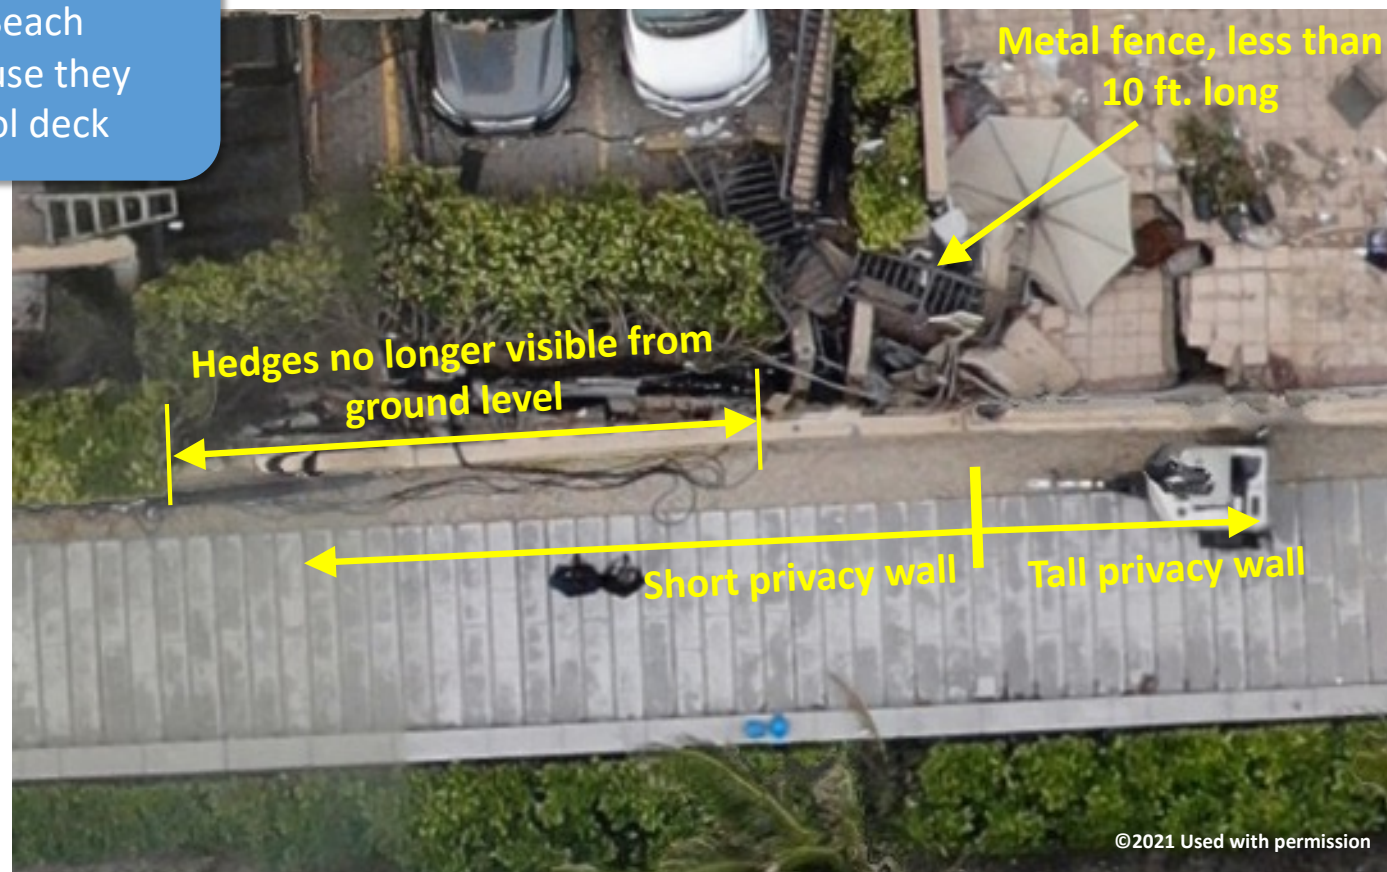
Key Point: Portion of hedges and the metal fence are not visible in Beach Access Walkway footage because they had already collapsed with pool deck

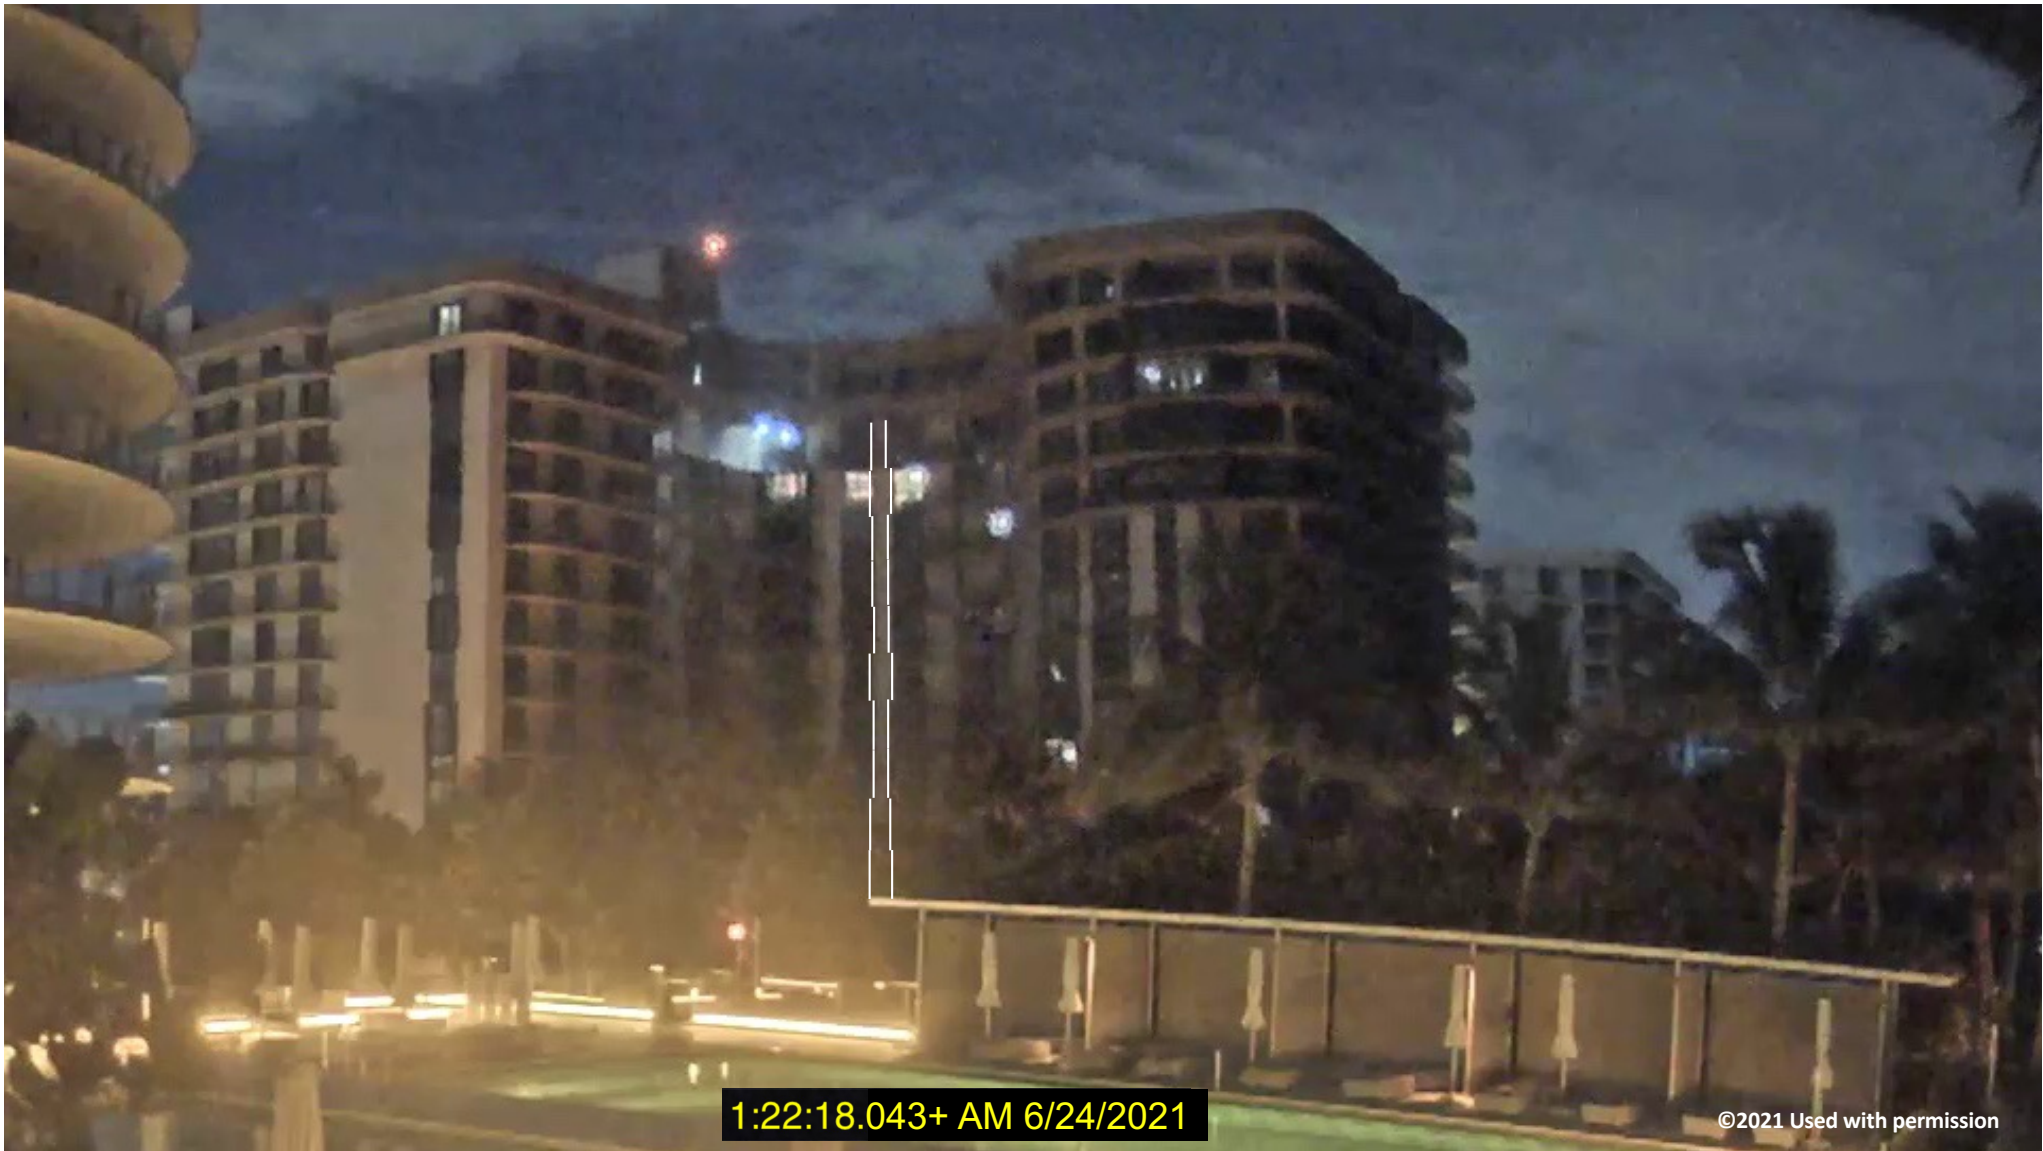
1. The unique façade shape moves uniformly downward, indicating that the failures that triggered the eastern part of the tower drop must have occurred below the 3<sup>rd</sup> floor.

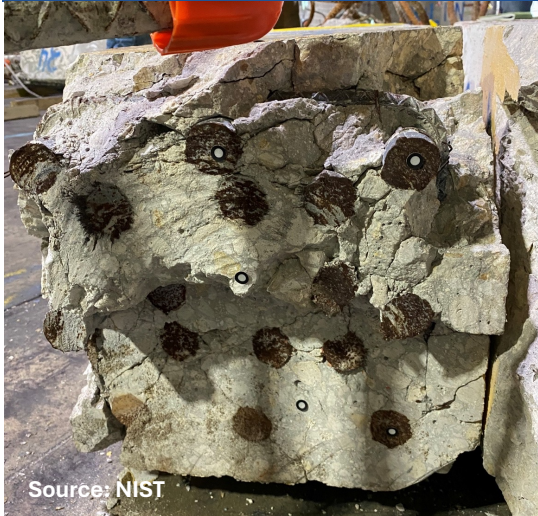
9.75 % vertical reinforcement in column at this splice, vs. 8 % maximum permitted (worst case at another column is 12.2 %)

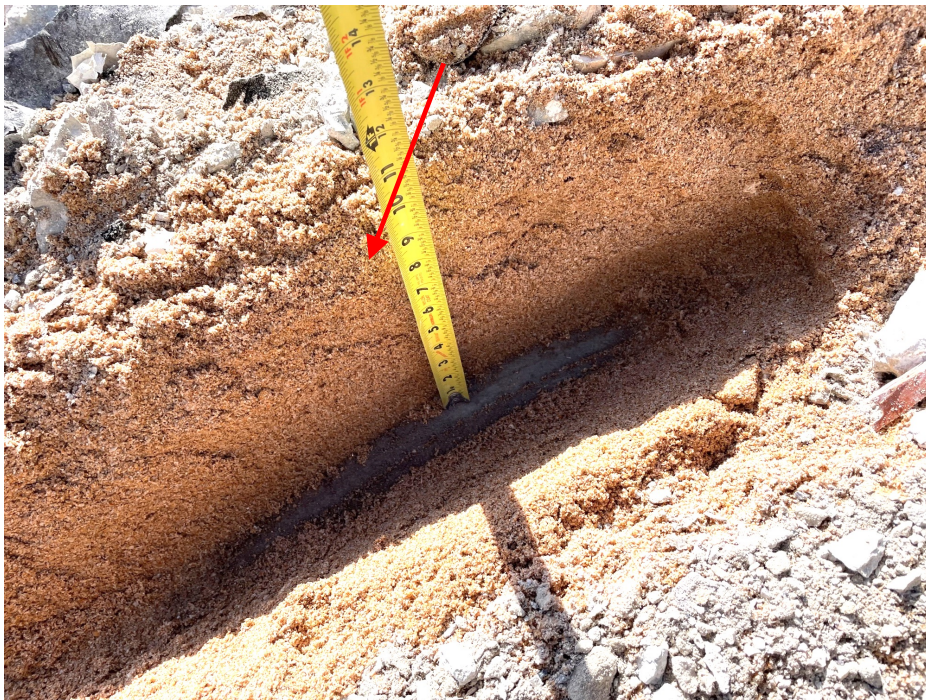
## Examples of Additional Fill and Paving

9 in. **added** sand setting bed

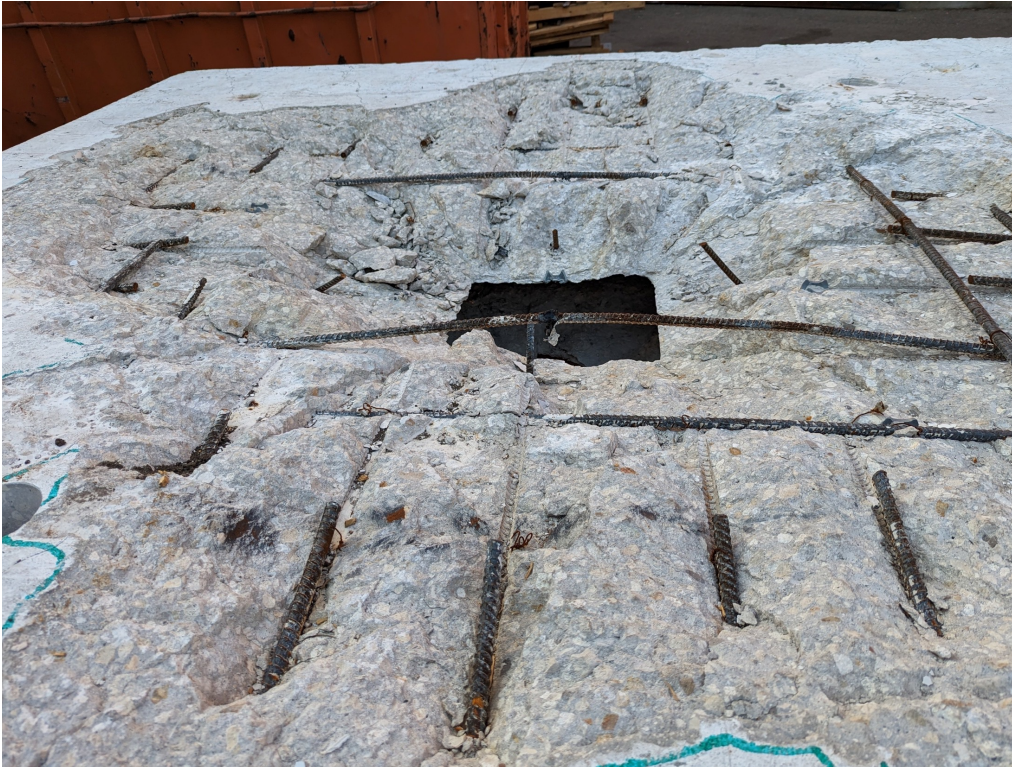
Post-test, uncorroded

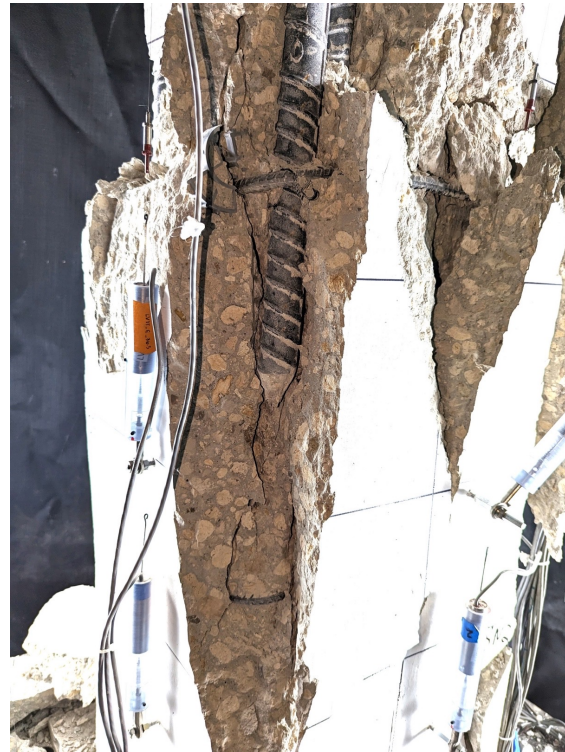
Several columns found with longitudinal bars where the lap splice is shorter than specified.

Left: specimen with short lap splice and sustained load

Below: close up of same specimen

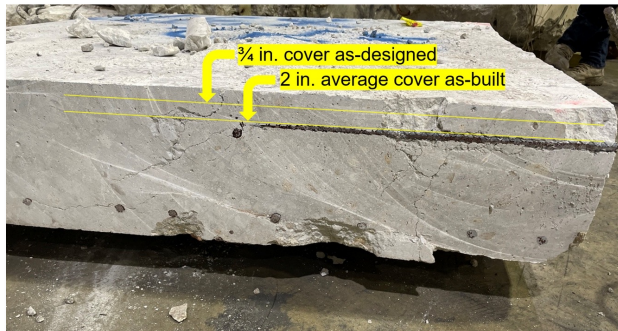
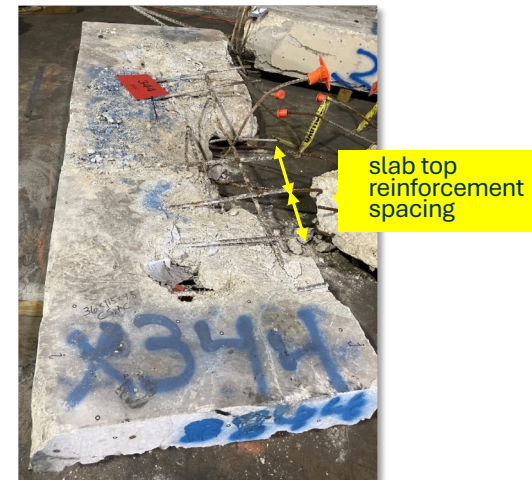
**Misplaced Slab Reinforcement**  
(pervasive)

Top Reinforcement in Pool Deck Lower than Design Requirements    Placement of Top Bars in Column Strips

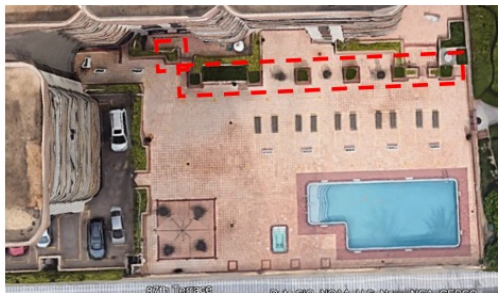
**Heavier, More Extensive Planters**  
(near north side of pool deck)

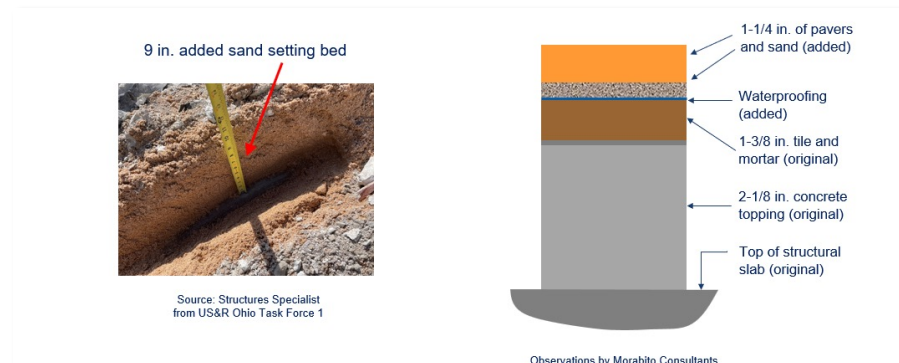
**Added Fill and Paving**  
(variable)

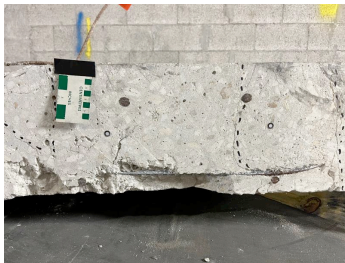
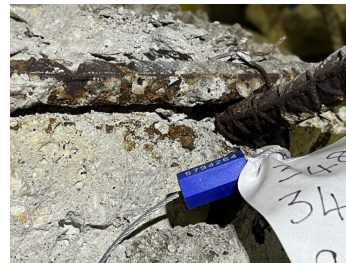
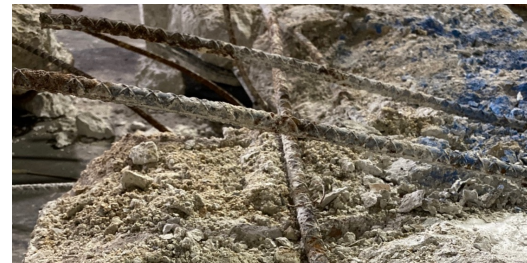
**Corrosion of Slab Reinforcement**  
(variable)

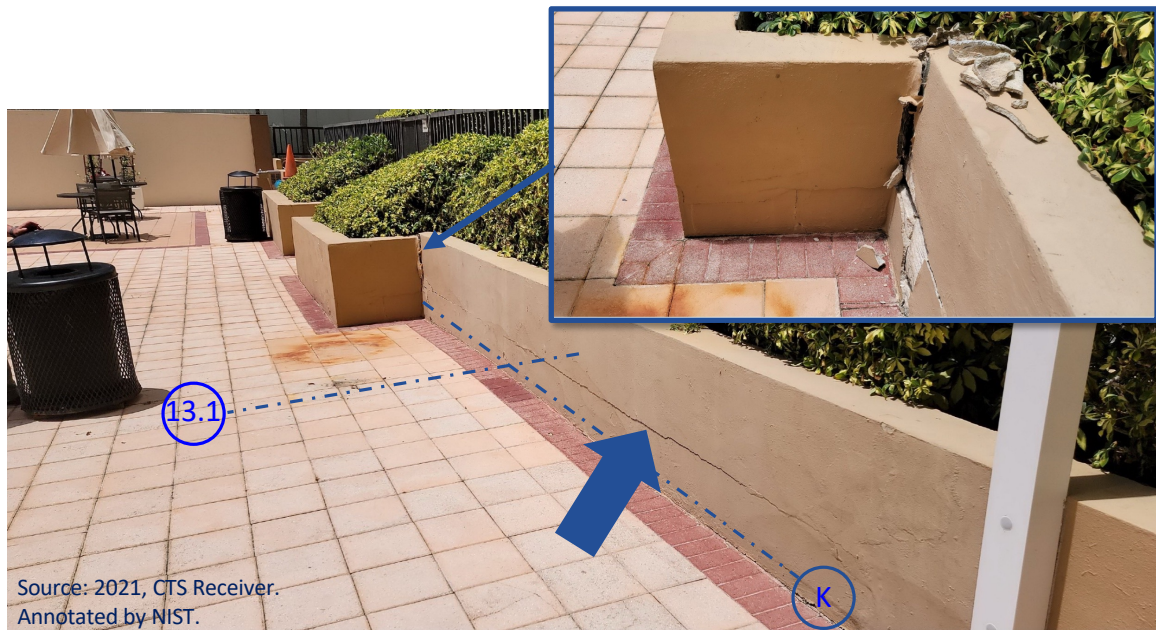
There were indications of severe distress in the pool deck at least three weeks before the collapse

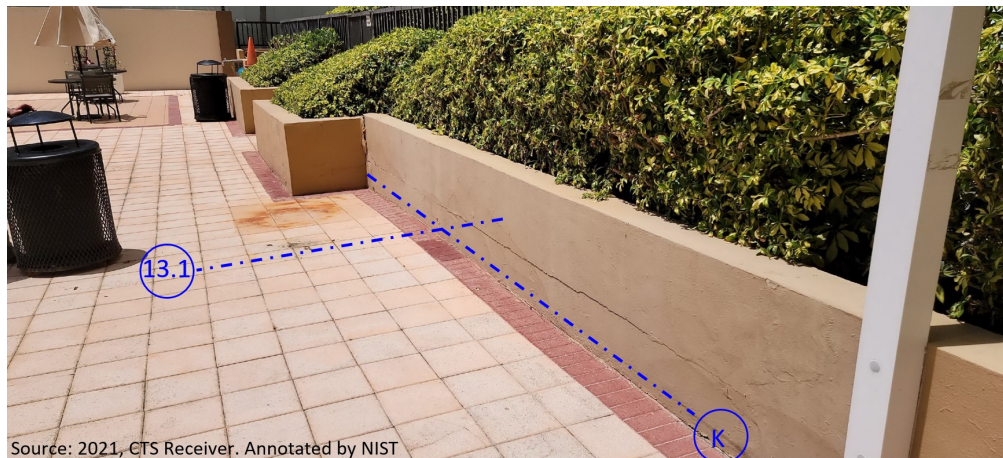
5. While there is strong evidence that the collapse initiated in the pool deck, we have not yet ruled out a failure initiation in some part of the tower that precipitated a collapse in the pool deck.
- There were indications of severe distress in the pool deck at least three weeks before the collapse.
  - There are also potential initiation points in the tower.

Damage to Pool Deck Planters Three Weeks Before the Collapse Indicated Severe Structural Distress
