**Photo C-1. NIST Nain Entrance – Front of the House shown with library on the left side and auditorium on the right side of entrance (view southwest)**

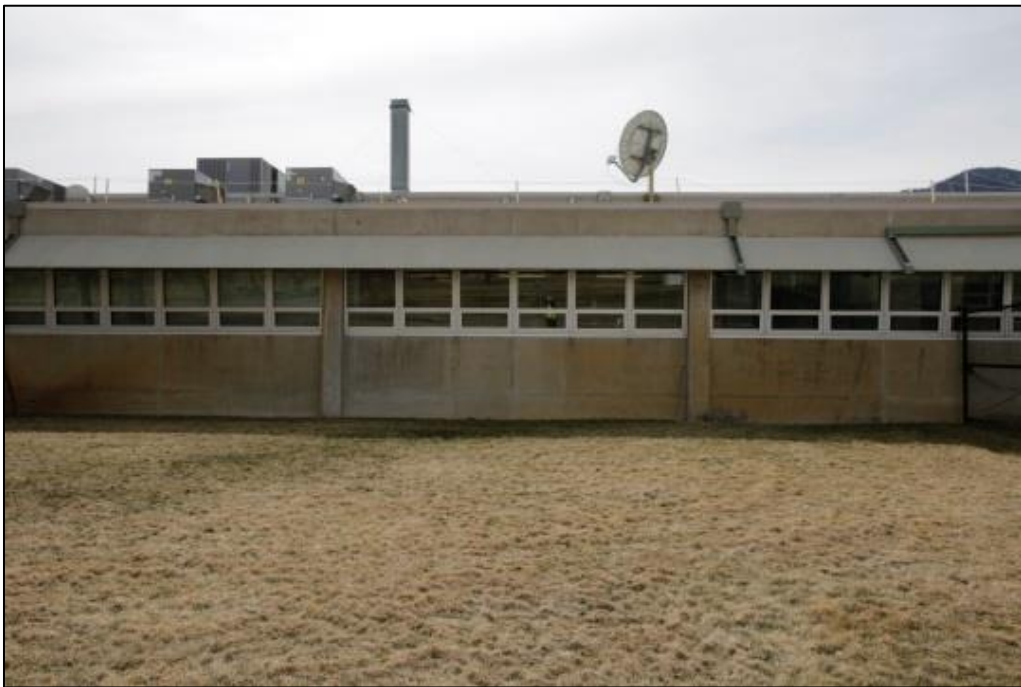
**Photo C-47. South and East Elevations of Wing 2 (view north)**

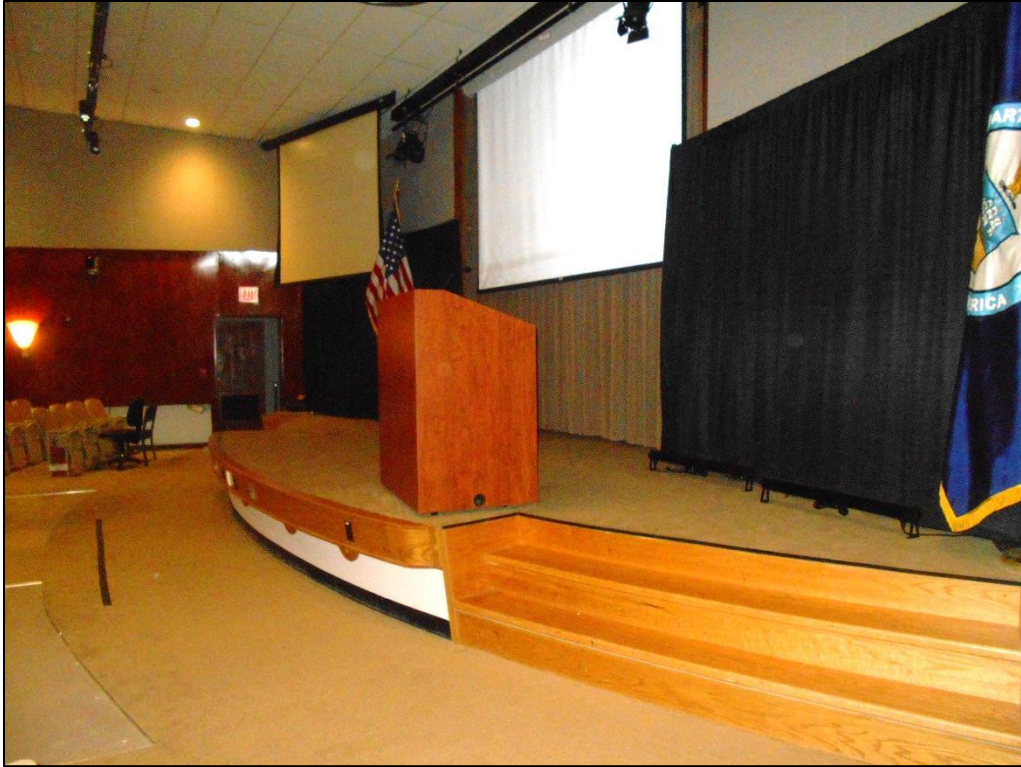
**Photo C-72. Auditorium Interior (view northeast toward stage and north wall)**

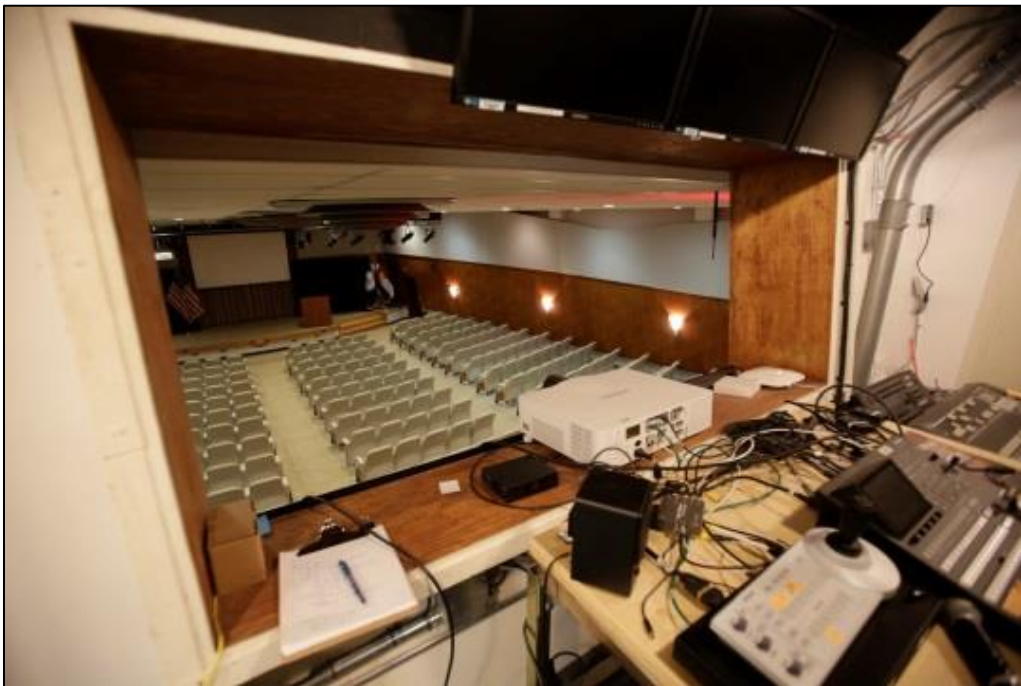
**Photo C-77. Projection Room (view southeast)**

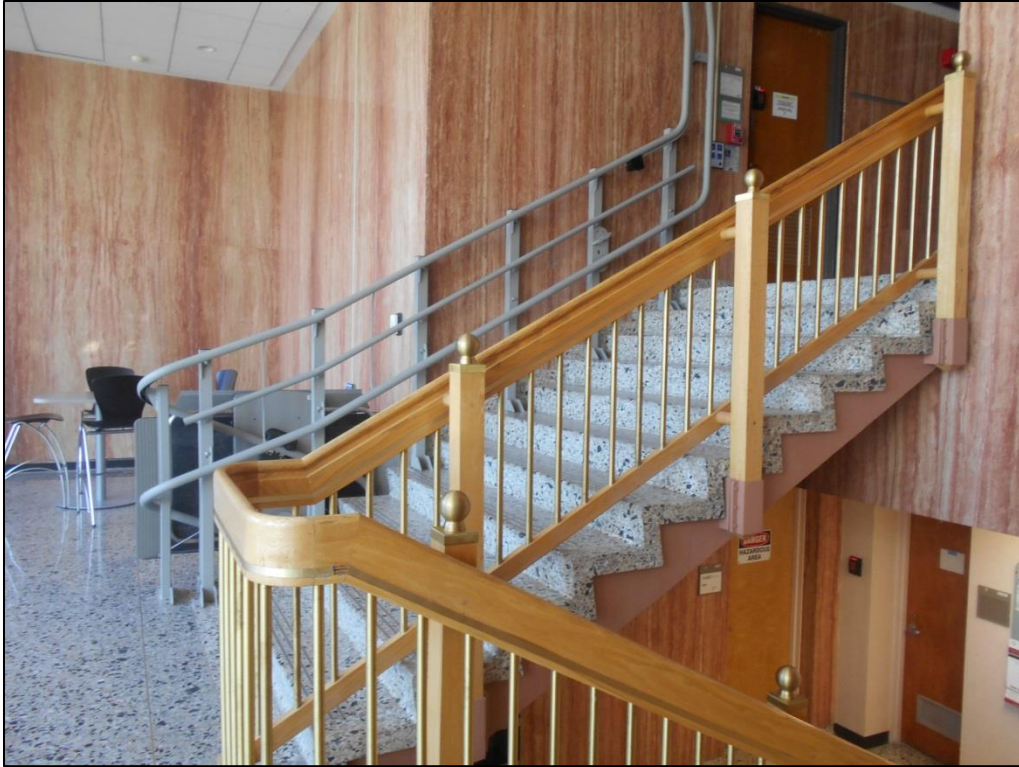
**Photo C-99. Lobby Stairs to Levels 1 and 2 of the Spine (view southeast); the handrails were originally 1.5-inch steel pipe**

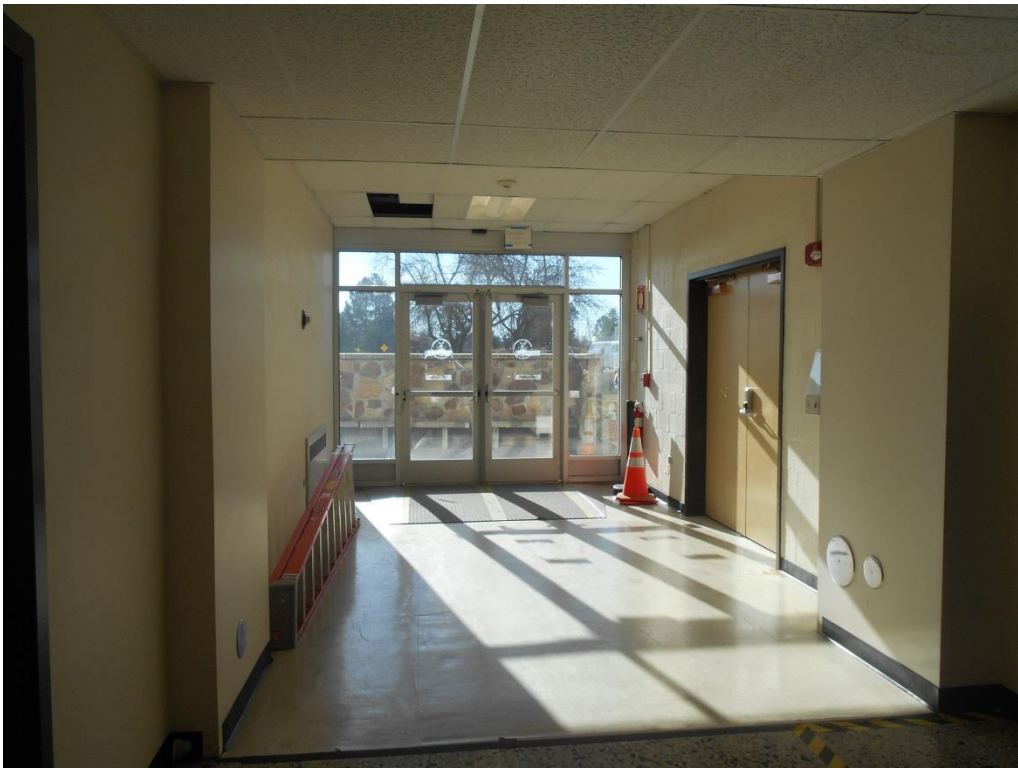
**Photo C-104. East End of Corridor and Former Location of Original Conference Room (view southeast; the doors and finishes in this area are not original)**

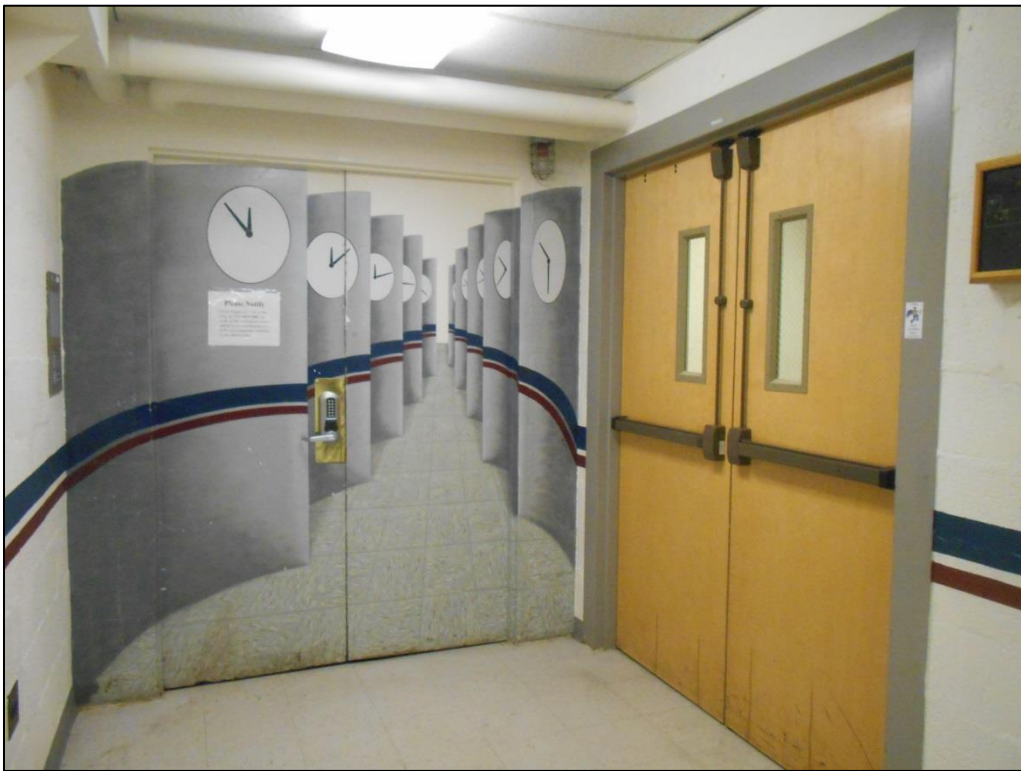
**Photo C-134. Painting at the South End of the Level 2 Corridor**
